RISK Assessment® Report

RISK ASSESSMENT®

ADDRESS: 8125 Lankershim Blvd. North Hollywood, CA 91605

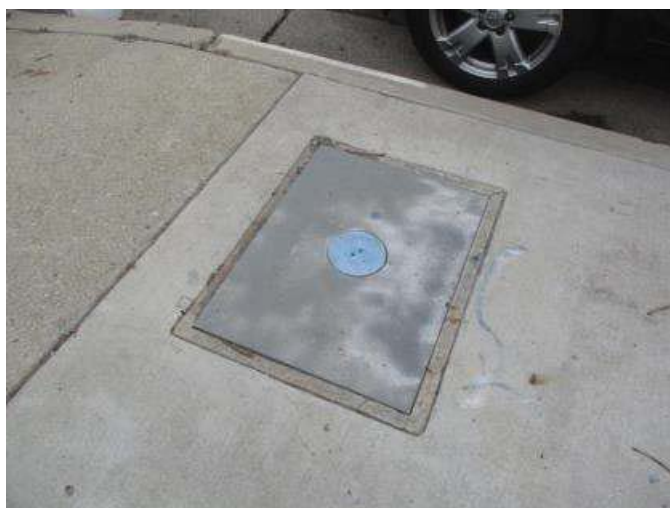
Overall the plumbing system, both supply lines and the waste lines, appear to be serviceable. No significant defects were observed and it appears that typical and routine maintenance is all that will be needed for the near future.

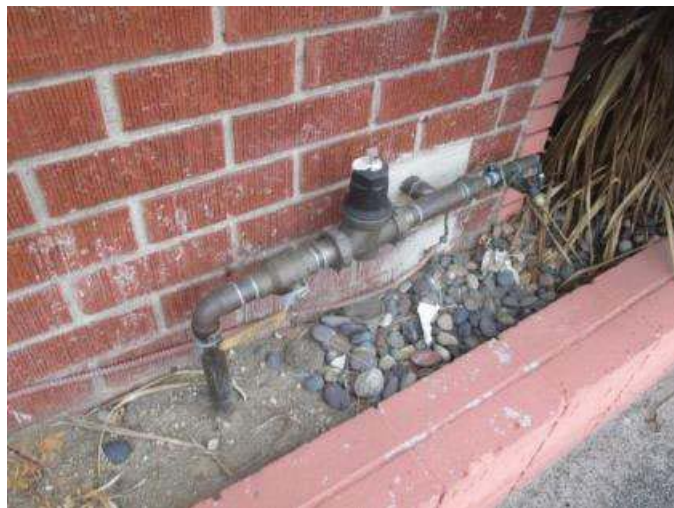
There was a pressure regulator observed on the water supply system. It is not known how well or if it is functioning, as this is beyond the scope of a general visual inspection.

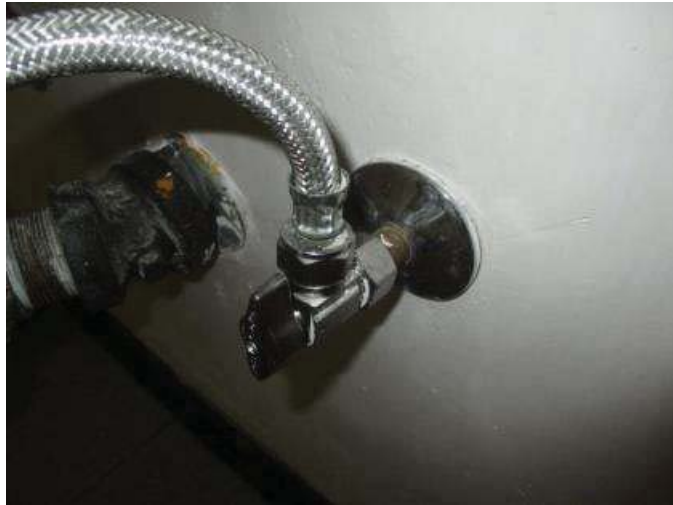
The interior piping that supplies the water throughout the building is made of copper where viewed.

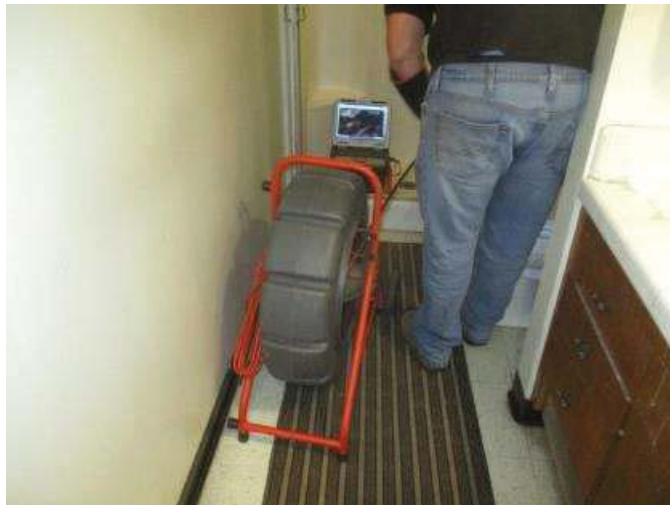
It is noted that this camera inspection was being done at the time of the general visual inspection. See this detailed report for the overall condition of the underground sewer lines.

A detailed Sewer Line Camera Inspection was being done. It is advised to have the Sewer Line inspection report reviewed in detail to determine the true condition of the sewer lines and what is the best course of action to help ensure a properly functioning sewer line system.

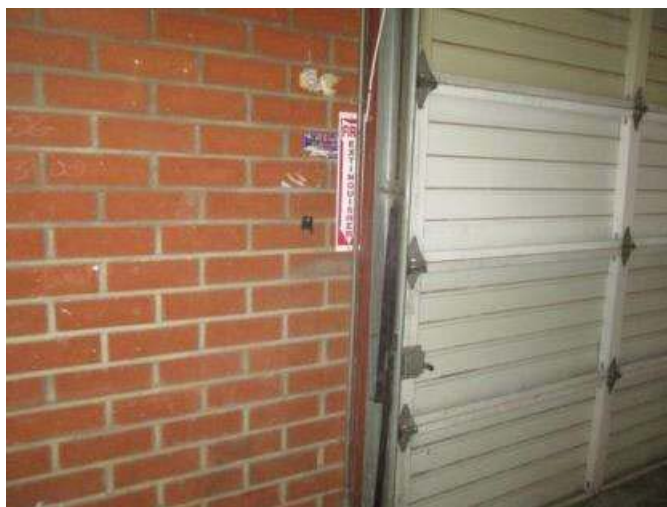
There is no fire suppression system installed for this site.

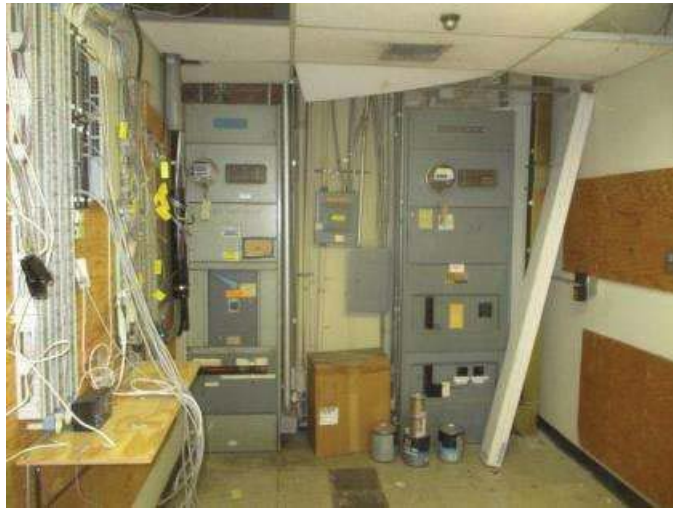
The system is in need of some repairs. These repairs do not appear to be overall significant but are recommended for health and safety.

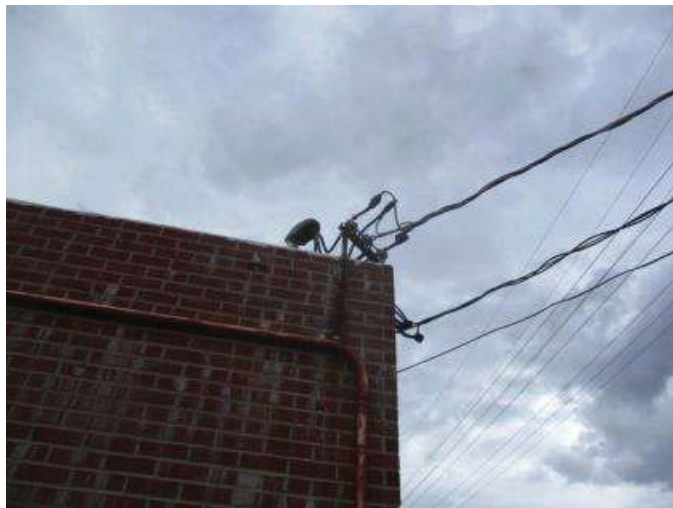
The electricity is supplied by an overhead line to the building.

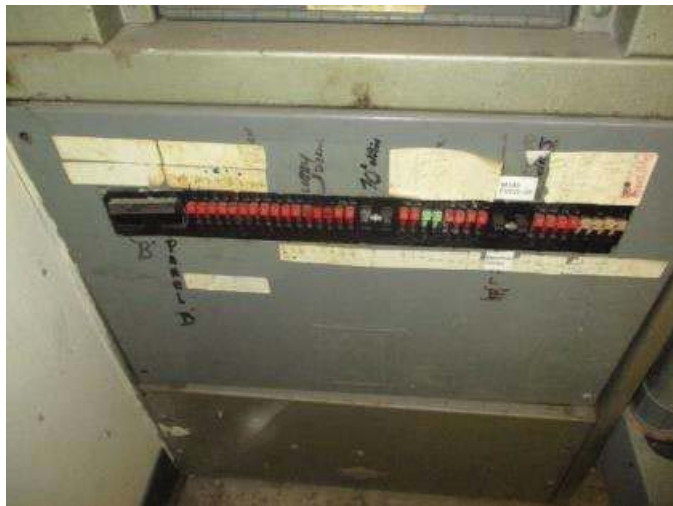
This panel and circuit breaker system is an old system. It is nearing the end of its expected life span. As with all older systems it will be more prone to failure due to its age and design. Some of these older systems have a reputation for unreliability, failing to trip, jamming, or overheating. Some electricians may recommend the panel be replaced and upgraded for safety.

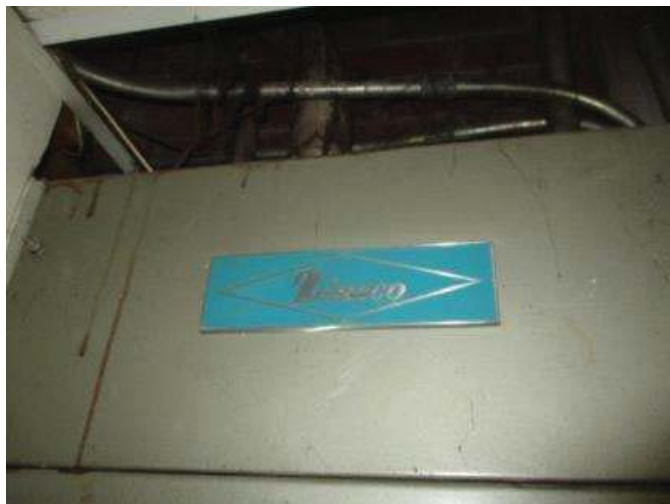
Zinsco Panels have been observed on the site. These panels are reported to not perform up to current safety standards. For further details please consult with a qualified licensed electrician who is familiar with this type of panel. The only way to fully determine the condition of these panels is to do intrusive testing and examination which is beyond the scope of this inspection but is recommended at this time for health and safety reasons.

Zinsco panels have been observed on the site. These panels have been reported to not perform as designed in a higher number of cases than is considered typical. Further review by a qualified electrician is advised at this time for safety however replacement is the typical recommendation.

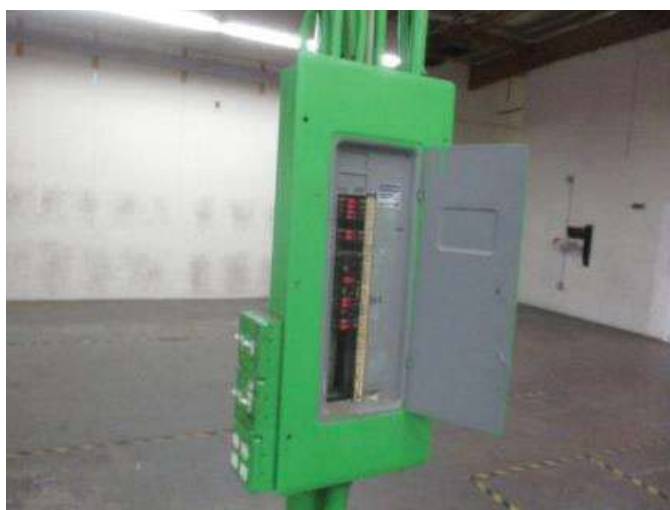
There is an electrical subpanel in various areas of the property.

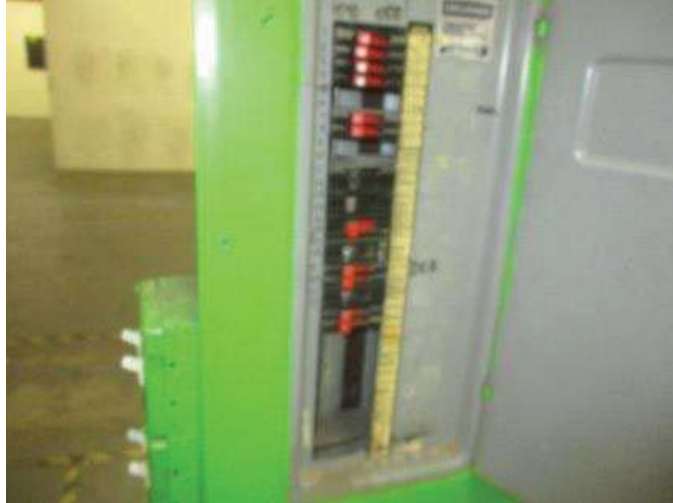
Needs Attention:

The subpanels in the units, or some of them, are observed to have been manufactured by Zinsco. These panels are reported to not perform up to current safety standards. For further details please consult with a qualified licensed electrician who is familiar with this type of panel. The only way to fully determine the condition of these panels is to do intrusive testing and examination which is beyond the scope of this inspection but is recommended at this time for health and safety reasons.

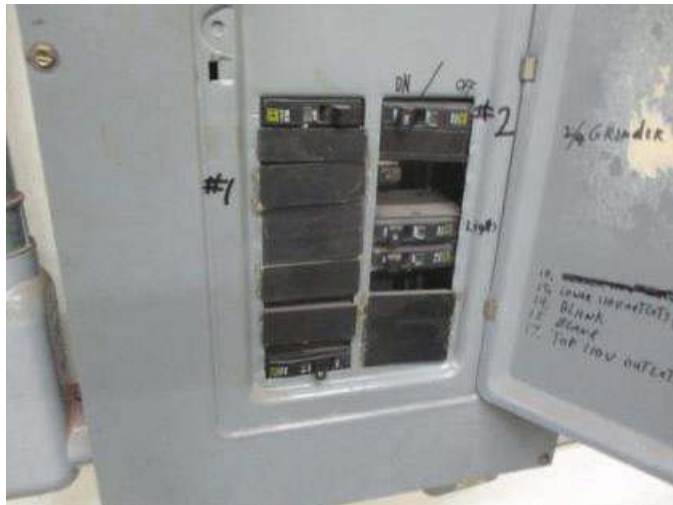
Needs Attention:

There are knock-outs missing at the panel leaving open spaces in the cover and there are exposed live electrical items as a result. This is inexpensive to correct but should be repaired for health and safety.

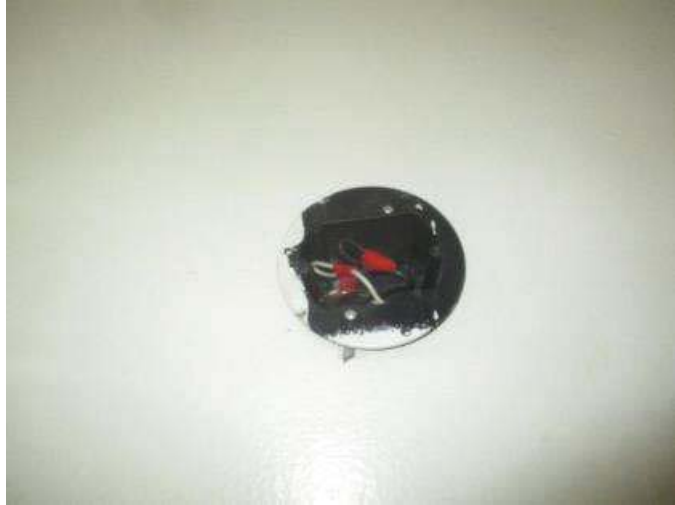
Needs Attention:

There is exposed wiring in areas. It may or may not be part of the system anymore and its function is unknown at this time. It should be removed or re-installed properly and not left in this condition.

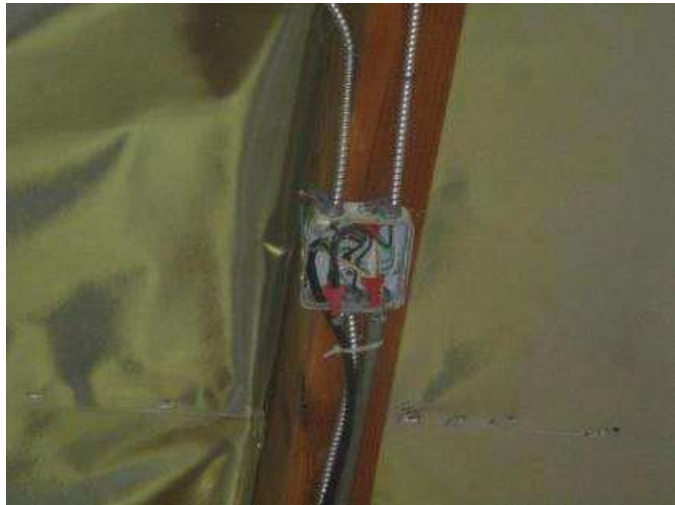
Needs Attention:

There are open junction boxes with wires exposed. Any such junction boxes need to have covers installed.

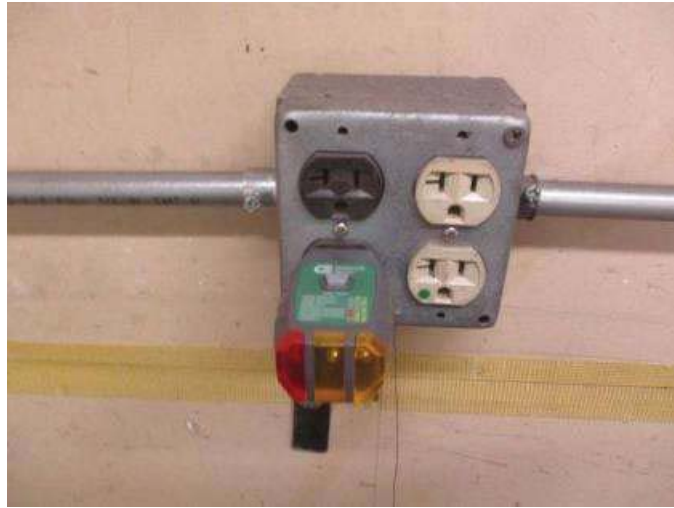
Needs Attention:

There are outlets that are dead and not working. Repairs are advised for health and safety.

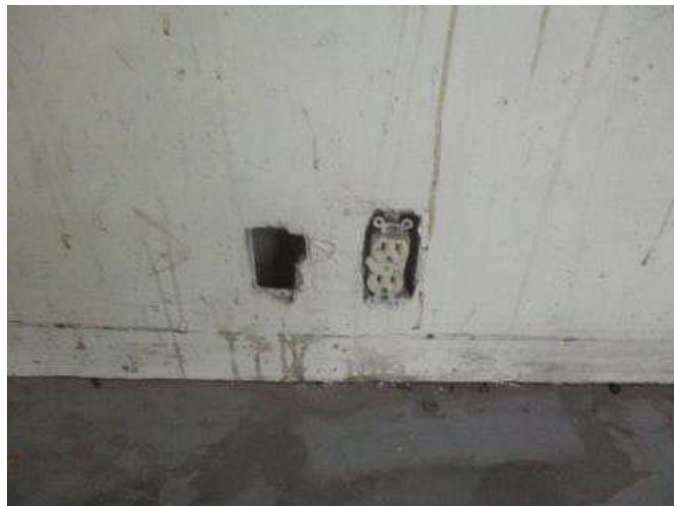
There are missing covers at some of the electrical outlets.

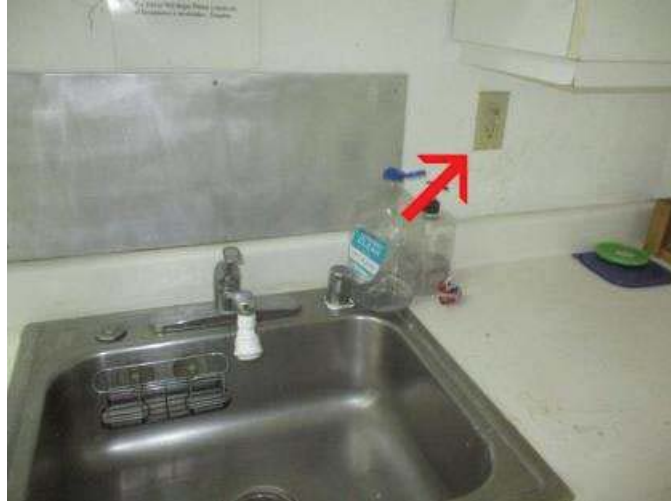
It is recommended that Ground Fault Circuit Interrupter (GFCI) safety outlets be installed at the exterior, restrooms, & any kitchen outlets. Not all the outlets may have these at the proper locations. This is advised for health and safety.

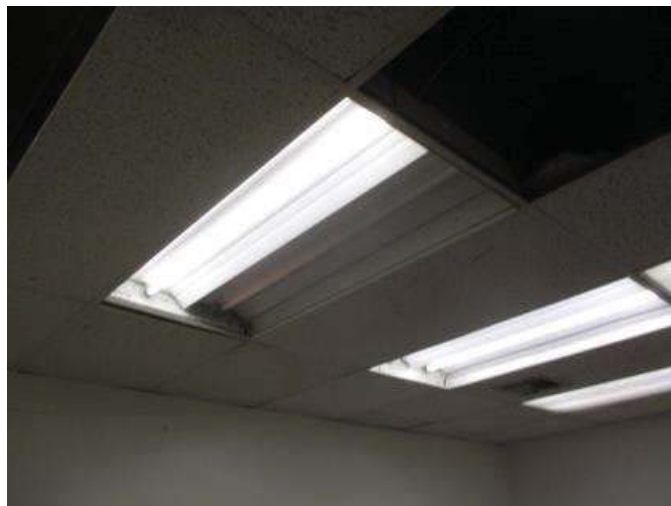
Needs Attention:

There are light fixtures that did not work when tested. This can be burnt out bulbs or deteriorated ballasts in fluorescent lights but it is not known exactly why they are not working.

There are fixtures that have missing covers.

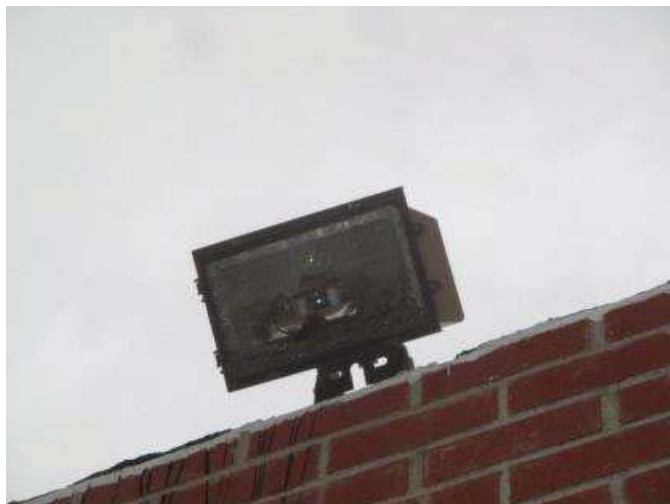
Needs Attention:

Exterior lighting is not part of this inspection but some broken exterior fixtures were noted.

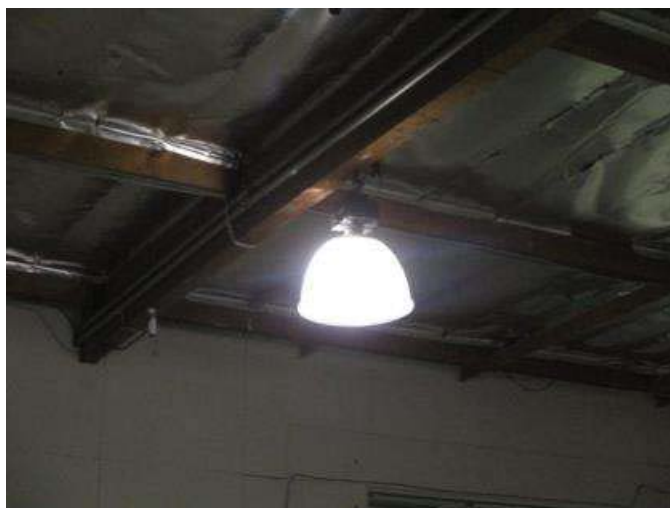
The lights in the warehouse area are not considered energy efficient by todays standards.

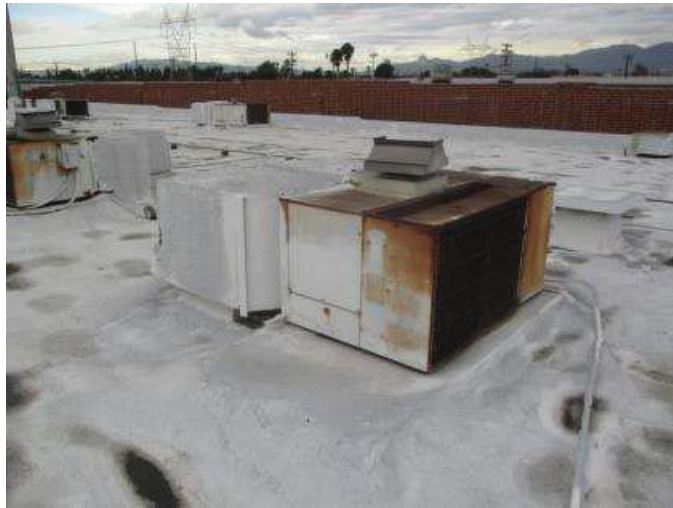
Due to the age and/or the overall condition of the HVAC system, immediate Repairs and/or Replacement are advised at this time.

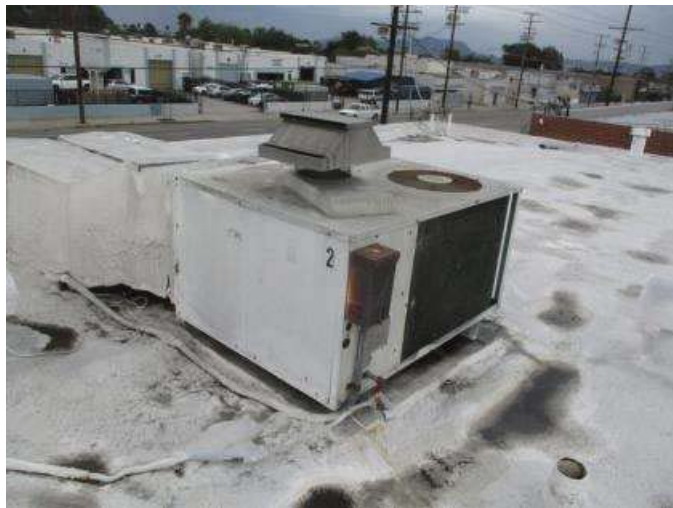
The heating and cooling systems for the building are known as "Roof Packages". This is the type of system where the gas heating furnace and the electric air conditioning (cooling) components are packaged inside one container and perform both functions from this common location on the roof.

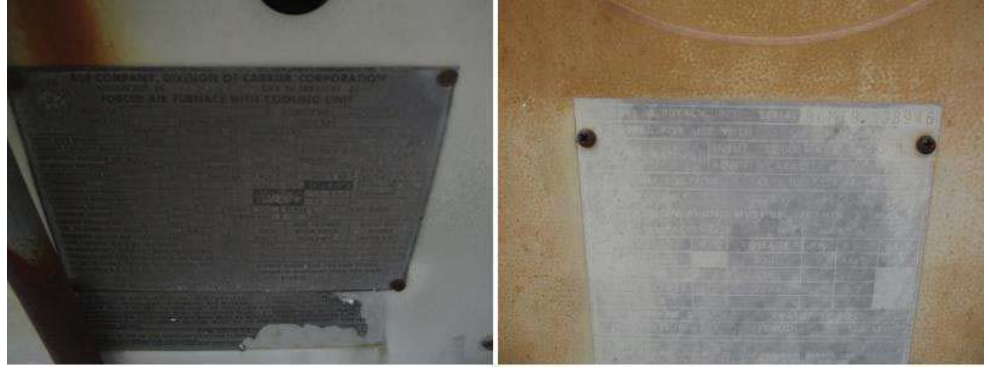
- #1 - The system is approx. 30 years old. (1990)
- #2 - The system is approx. 39 years old. (1981)
- #3 - It is unknown how old the unit is, but it appears older.
- #4 - It is unknown how old the unit is, but it appears older.
- #5 - The system is approx. 31 years old. (1989)
- #6 - It is unknown how old the unit is, but it appears older.
- #7 - The system is approx. 39 years old. (1981)
- #8 - It is unknown how old the unit is, but it appears older.
- #9 - It is unknown how old the unit is, but it appears older.

The heating units are aged and worn. Though they may still be functional and working, it is noted that this type of unit has a life expectancy of approx. 15 - 20 years. Depending on the quality of maintenance, these units are at or near this age.

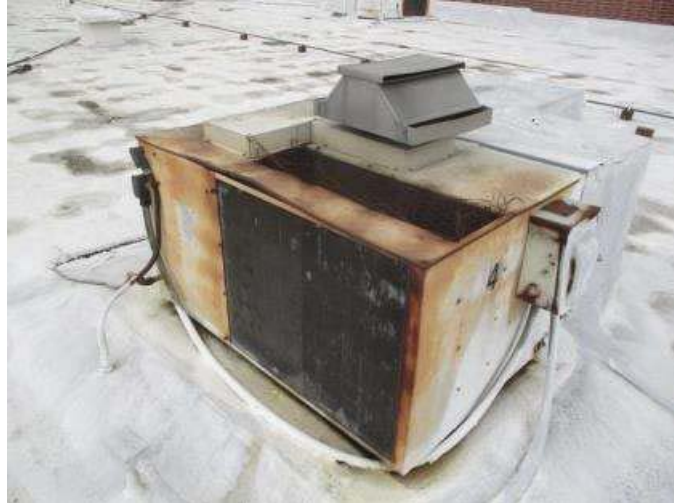
The refrigerant lines have deteriorated, damaged or missing insulation on them. This will cause them to be inefficient and they should have the insulation repaired. This is usually not an expensive item.

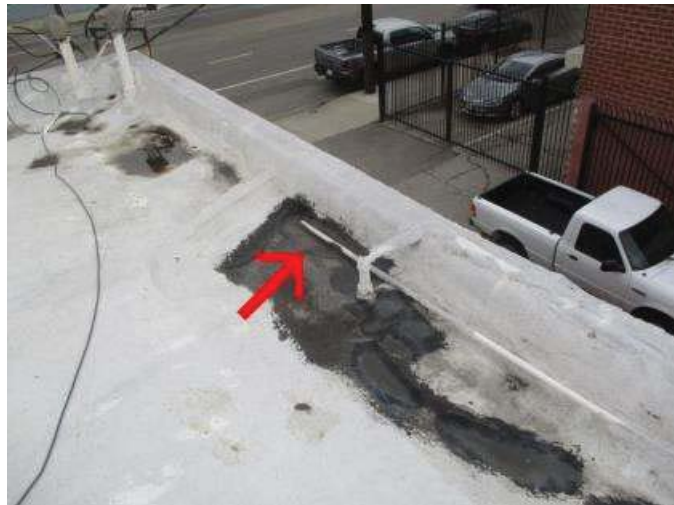
Needs Attention:

Several of the condensate lines are not connected to an approved drain and are draining onto the roof.

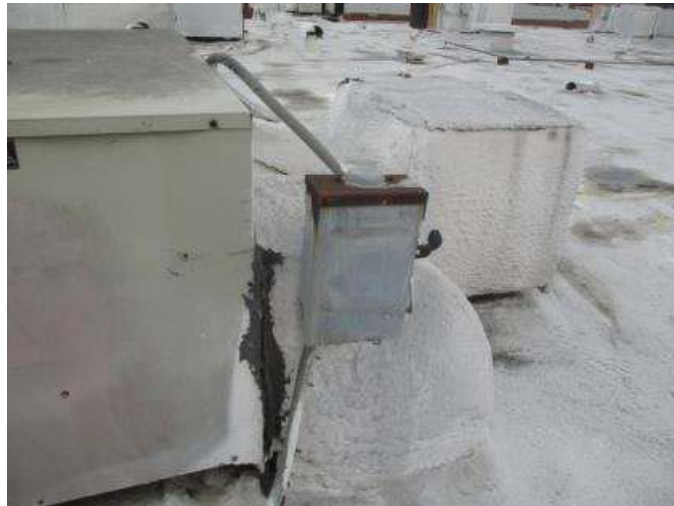
Serviceable Where Viewed.

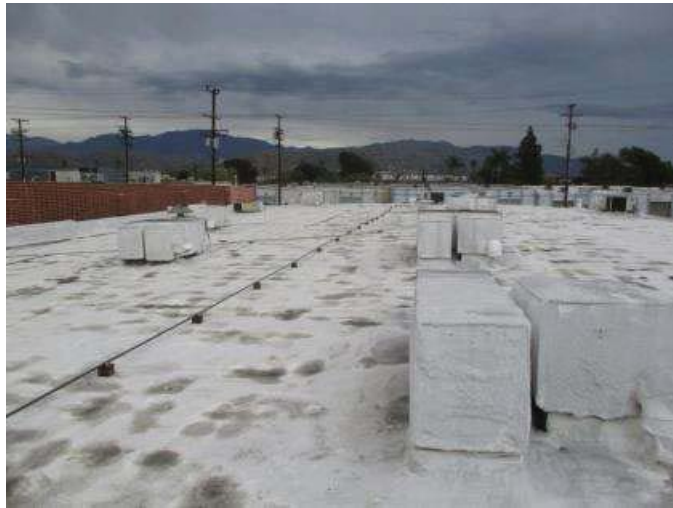
Review by a qualified roofing contractor is advised at this time and all needed repairs or maintenance should be done.

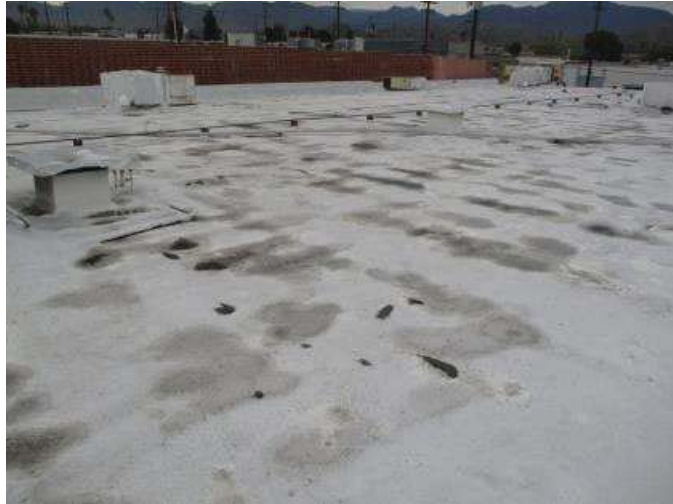
Needs Attention:

There are areas of standing water on the roof during the inspection. Standing water will accelerate the deterioration of roofing materials affected. It is advised to eliminate these areas of ponding by improving the slope of the roof wherever needed, or to reinforce affected areas where slope improvement is impractical.

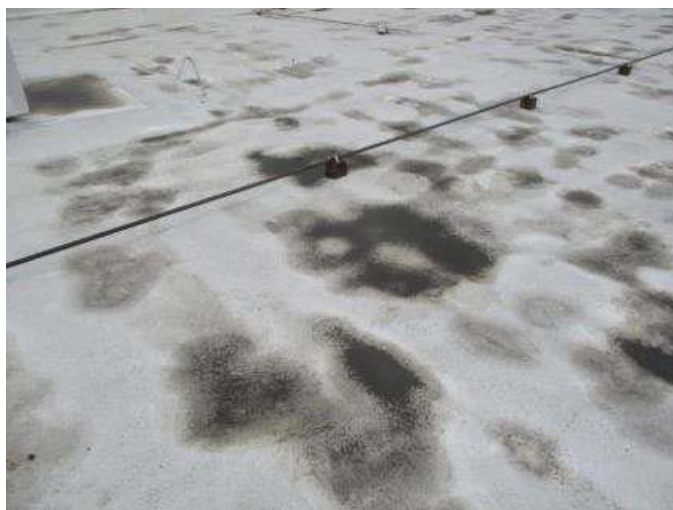
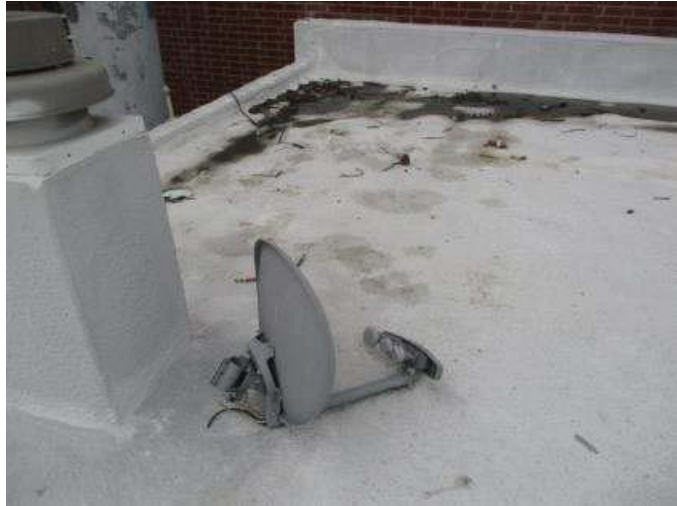
There is debris on the roof. It is advised to have this removed.

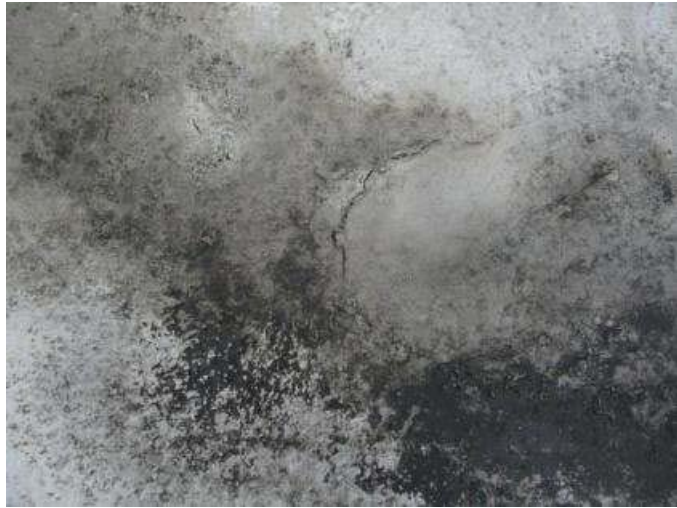
There are penetrations through the roof material. Repairs by a qualified roofing specialist is advised to ensure the roof system is a reliable moisture barrier.

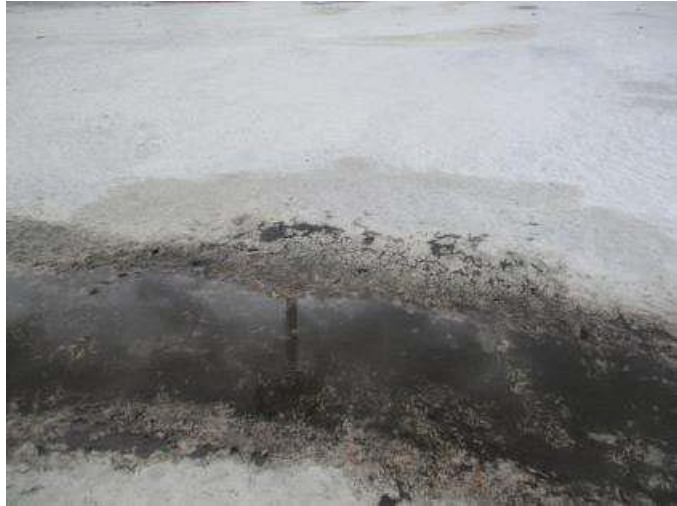
The roofing system is showing signs of general wear and age.

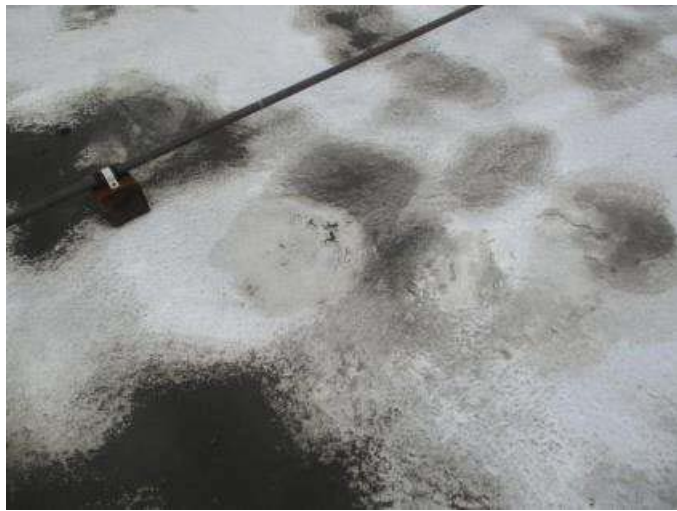
Needs Attention:

There are bubbled areas of roofing material. This is an indication that some moisture has gotten under the material.

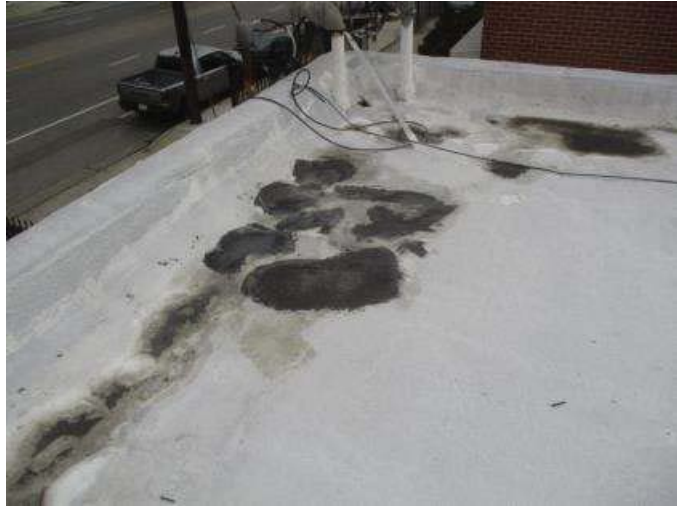
Needs Attention:

It is noted there are areas of the roof that have had patching and or repairs done to them. This is usually an indication that there have been leaks and past issues. It is advised to have full disclosure by the seller as to the history of any roof leaks.

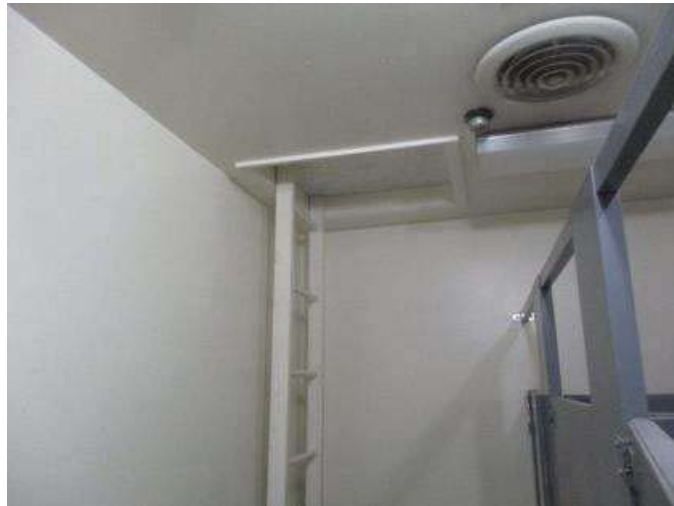
The attic access is in the bathroom

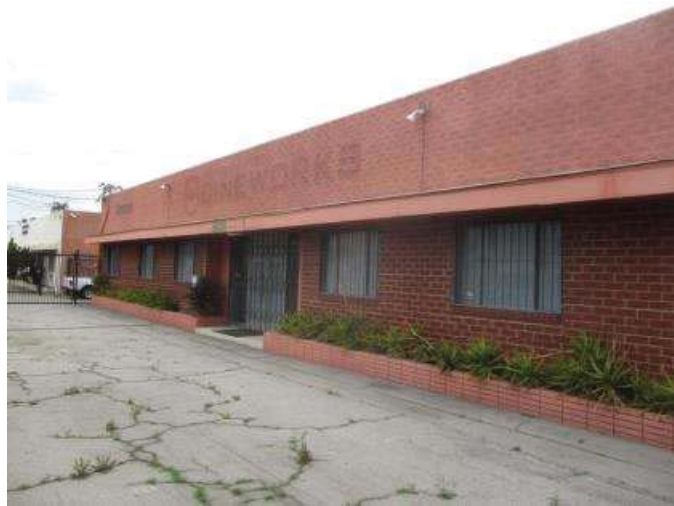
Overall the structure appears generally serviceable, however there are some areas in need of further review at this time for health and safety by a qualified structural specialist.

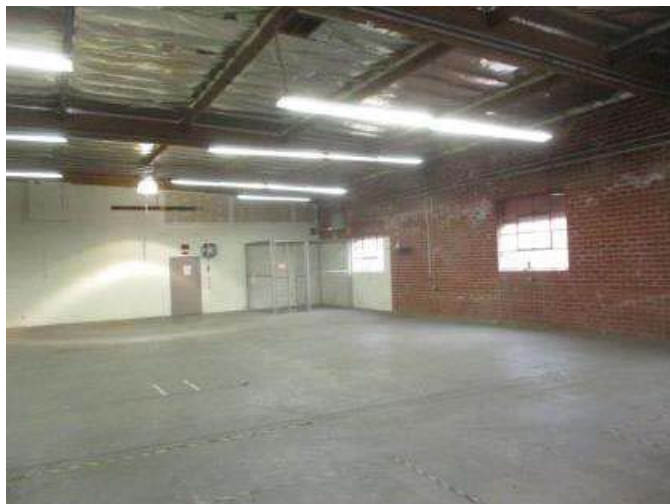
The building is supported by a slab foundation system.

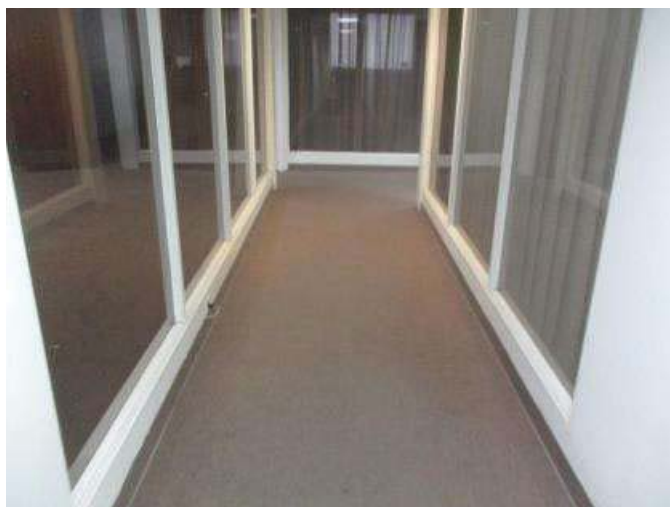
This building is on a monolithic slab of concrete.

There were no observable signs of significant settlement or deflection in the slab from observing the finish flooring. It appears to be performing its function of supporting the structure; however, the actual slab itself was not seen and it may appear different once the finish flooring is removed.

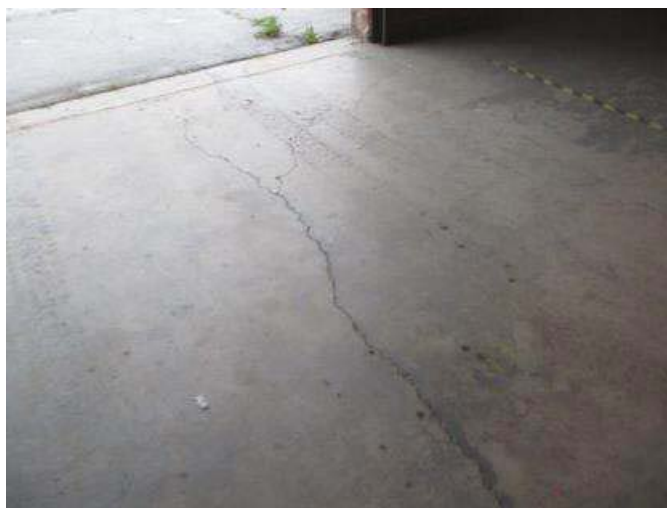
There are cracks in the slab that appear to be typical for the age and style of construction. However if you need a more detailed evaluation it is advisable to contact a structural engineer or a foundation specialist.

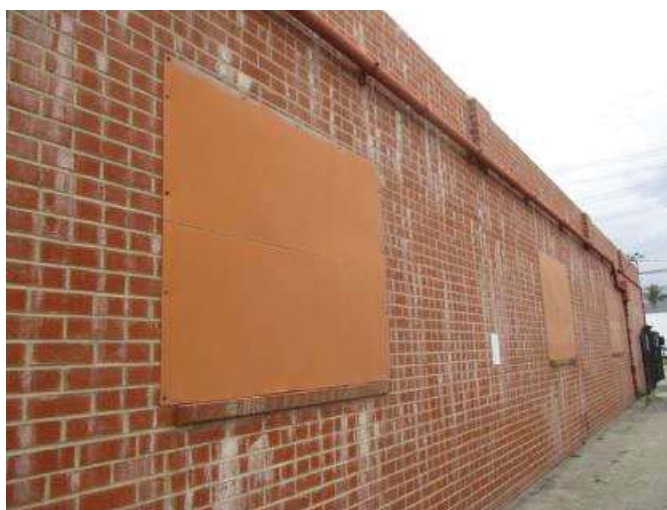
The building appears to be a reinforced brick structure.

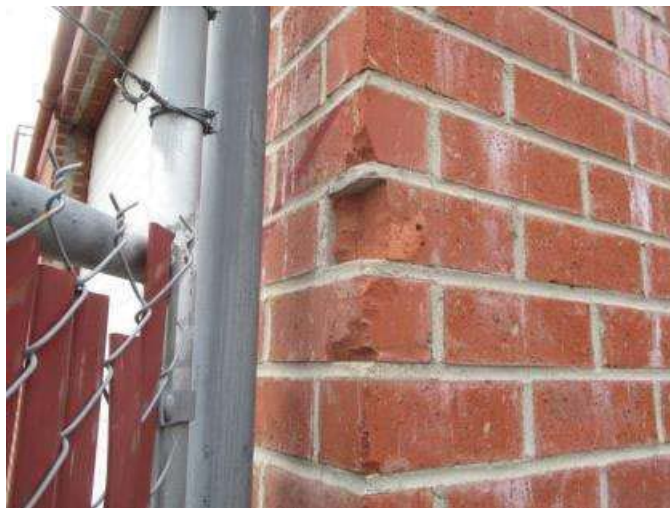
Needs Attention:

There is typical damage in the exterior walls.

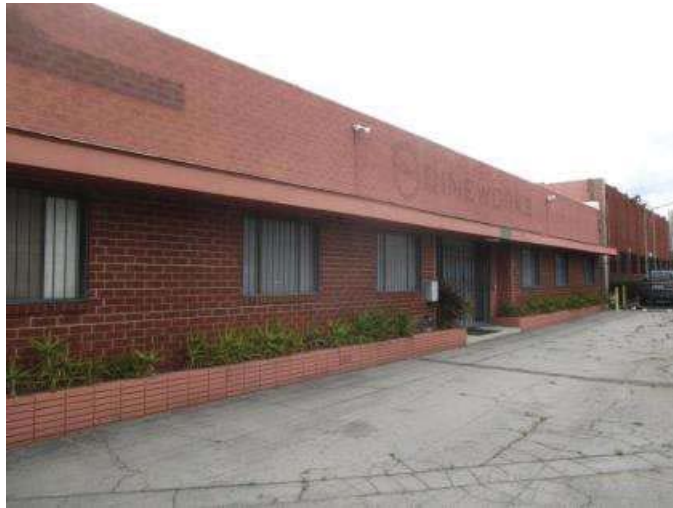
Overall the exteriors are generally serviceable, however there are some areas in need of repairs or maintenance at this time.

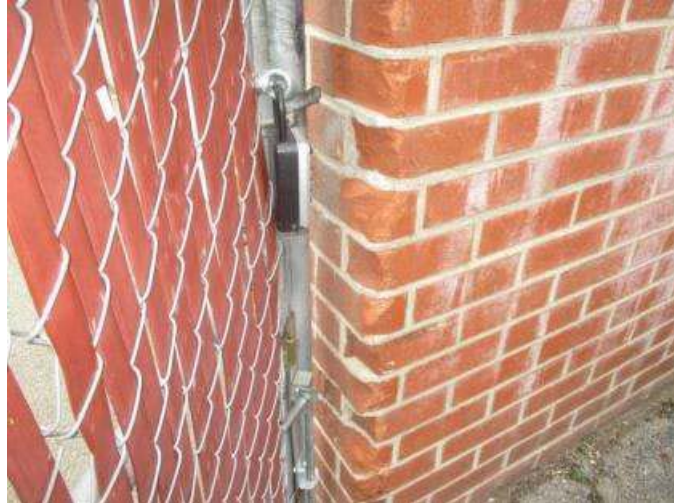
Needs Attention:

There are areas of damage to the exterior walls.

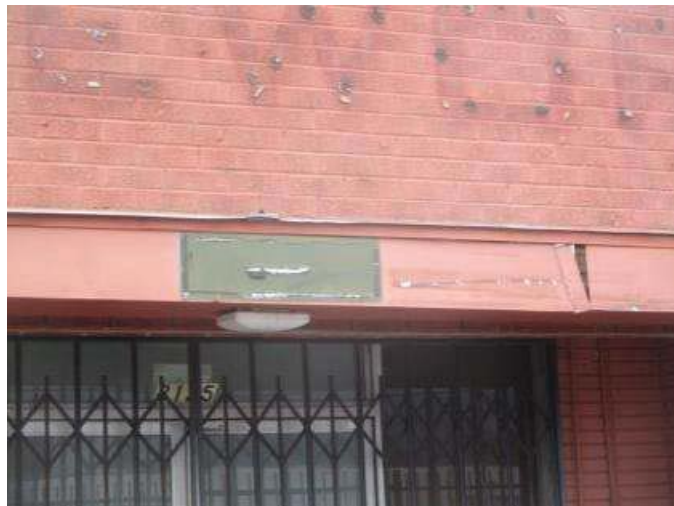
The trim has areas of weathering and damage.

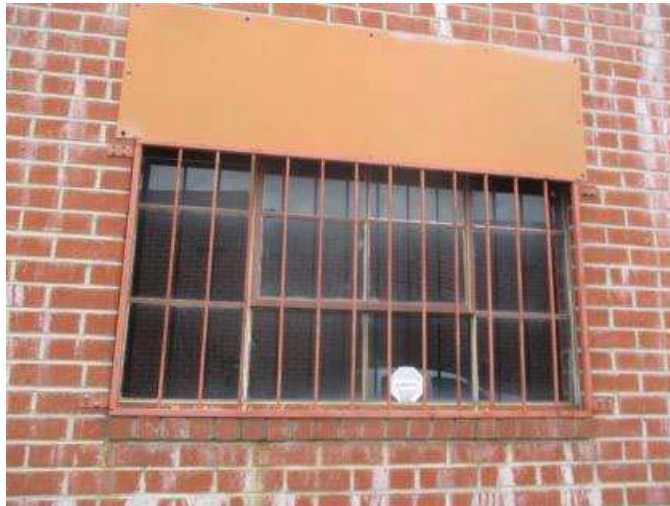
The exterior window surfaces are metal.

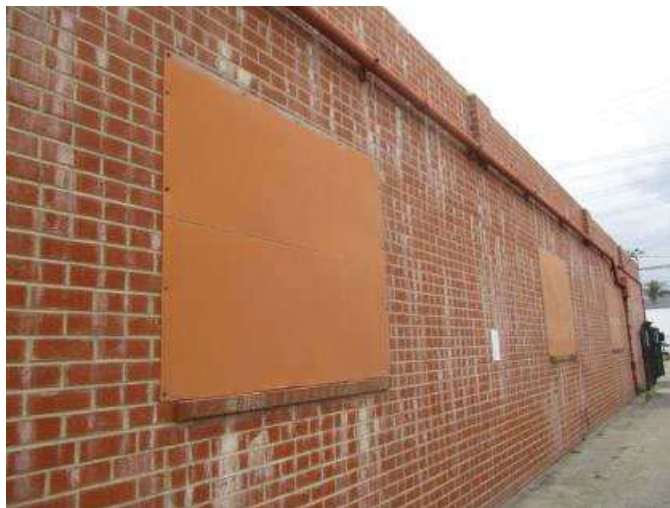
Needs Attention:

There are windows that are boarded up.

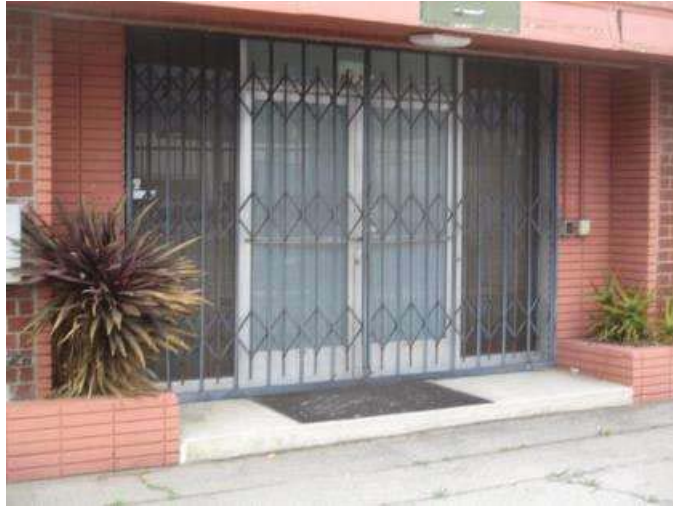
The exterior door surfaces are metal.

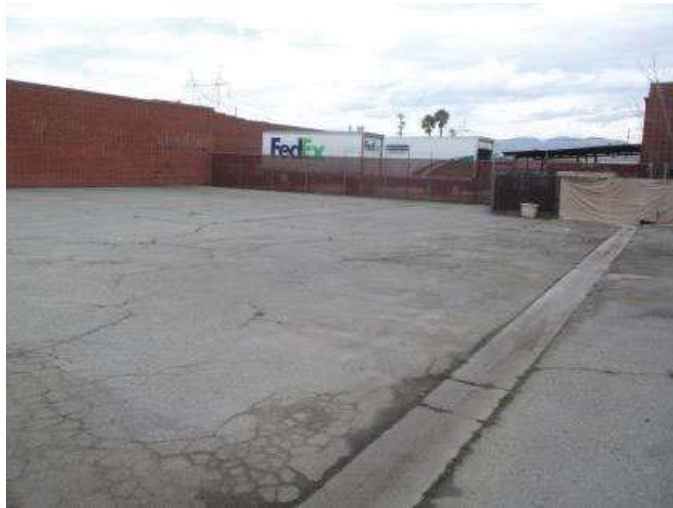
Overall the grounds exhibit wear, damage or deterioration to the point repairs are advised.

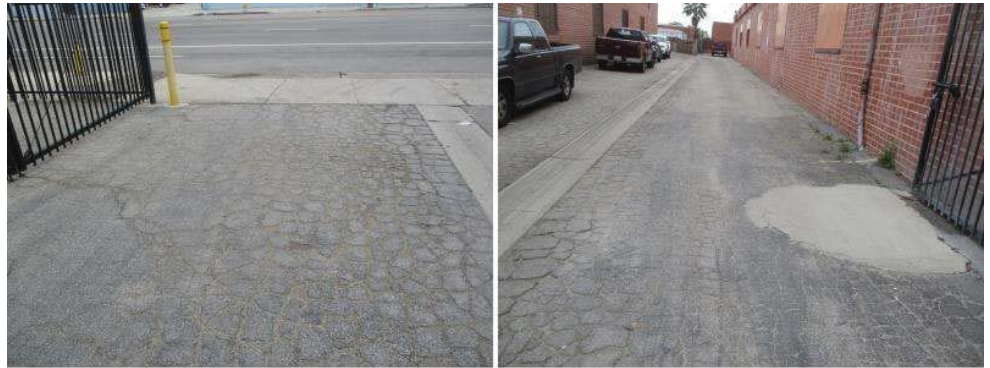
Needs Attention:

The driveway area surfaces are deteriorated and in need of being resurfaced at this time.

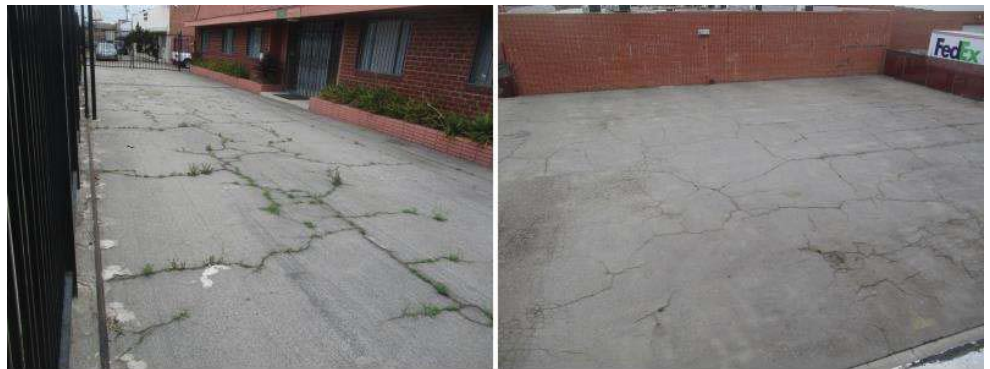
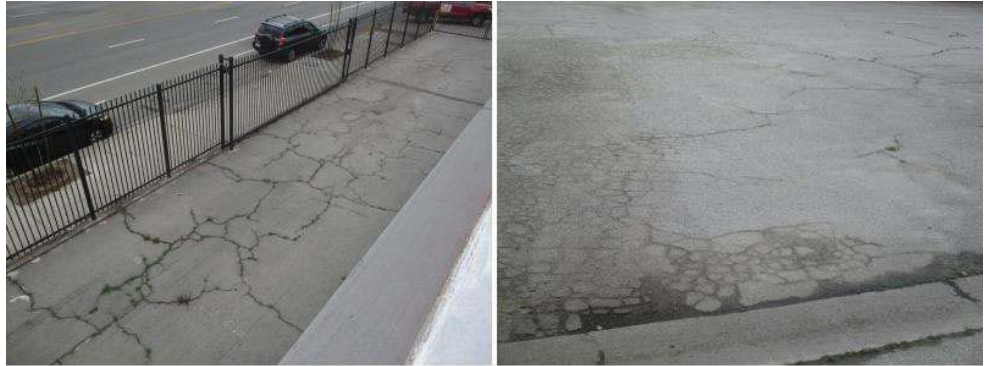
Needs Attention:

There are areas of wear and deterioration. It is advised to have some repairs made to areas exhibiting excessive wear, then reseal and restripe the entire parking lot.

Some repairs to the parking areas are needed then it is advised to have the parking areas fully resealed and restriped at this time.

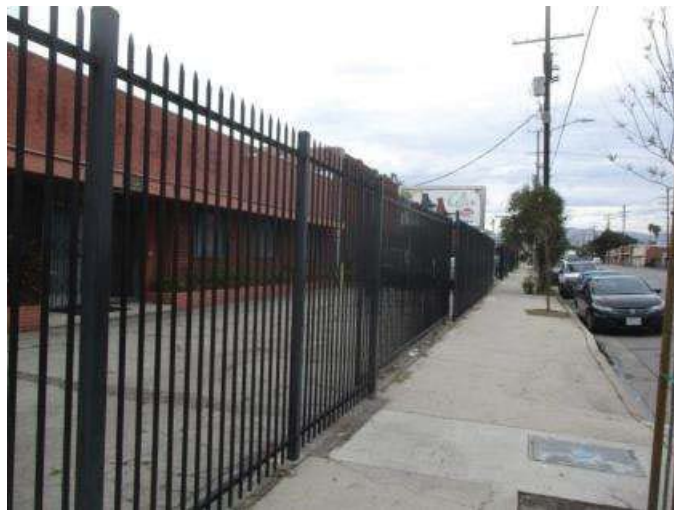
Serviceable.

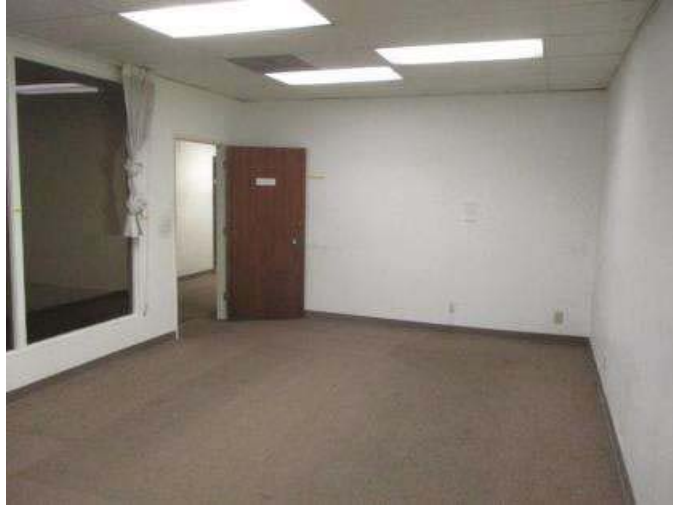
The interior areas are generally aged and worn.

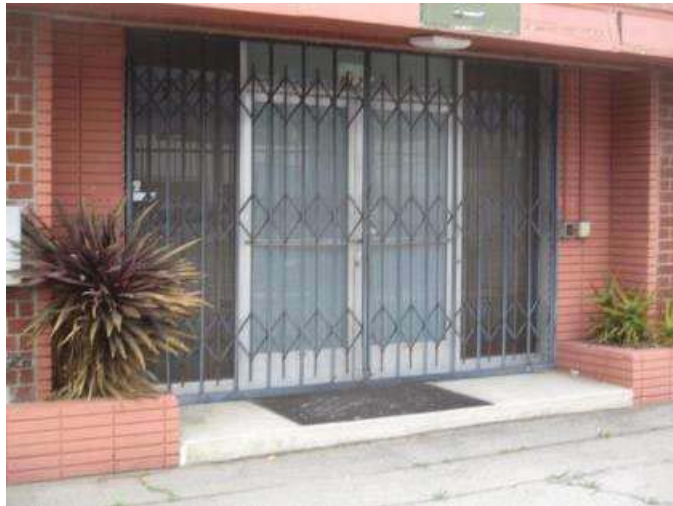
Serviceable overall.

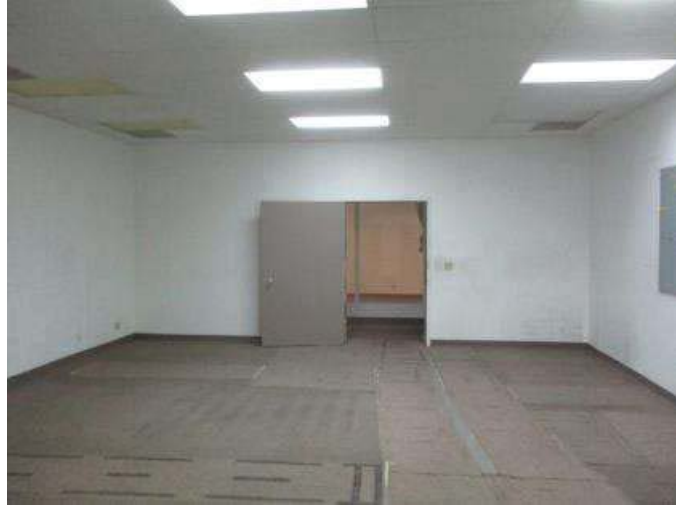
The office areas show excessive wear and tear. Upgrades are advised at this time.

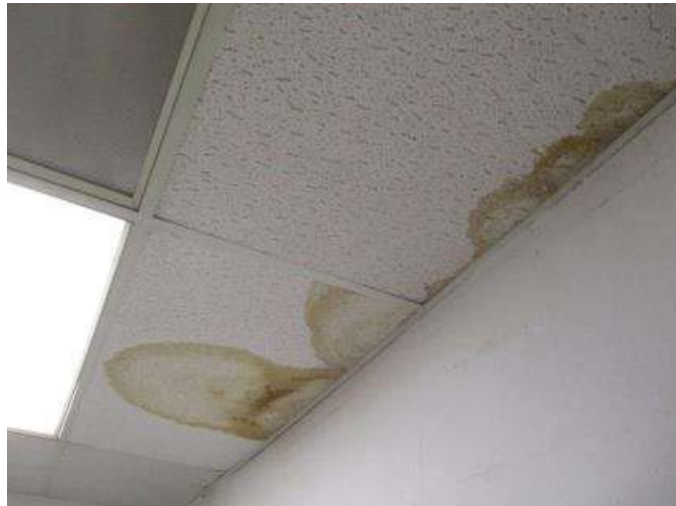
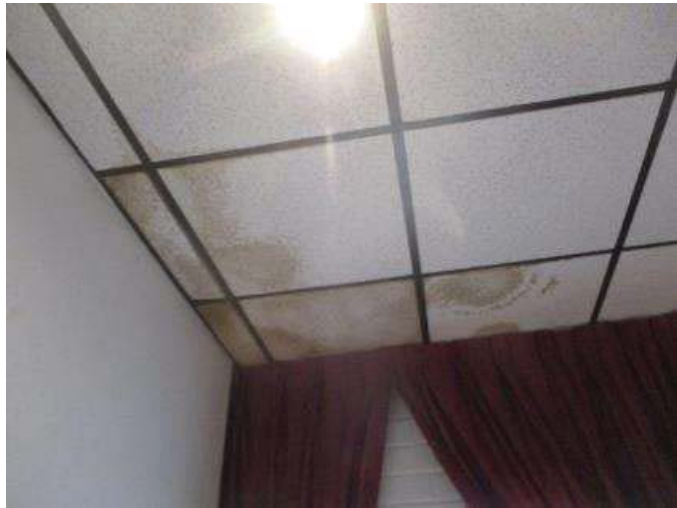
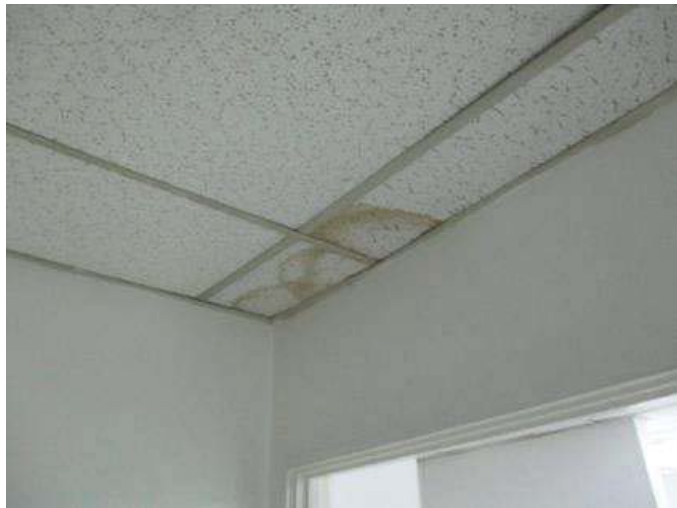
Needs Attention:

There are areas of moisture stains and/or damage on the ceiling.

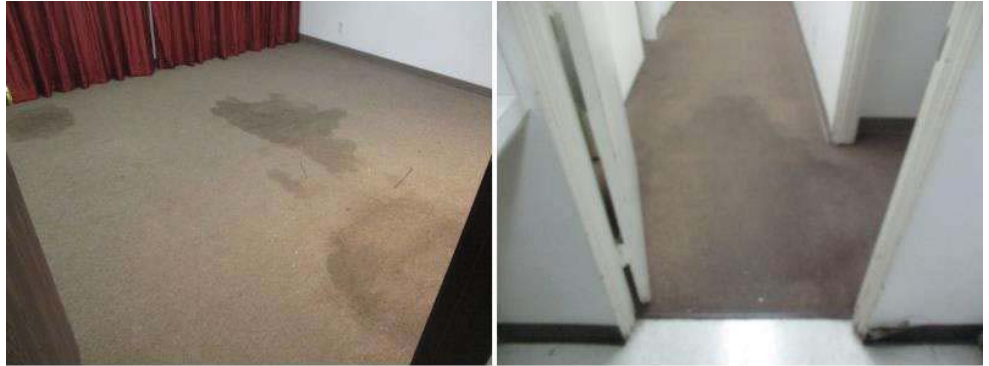
Needs Attention:

The flooring is worn and stained.
