RISK Assessment® Report

RISK ASSESSMENT®

ADDRESS: 8125 Lankershim Blvd. North Hollywood, CA 91605

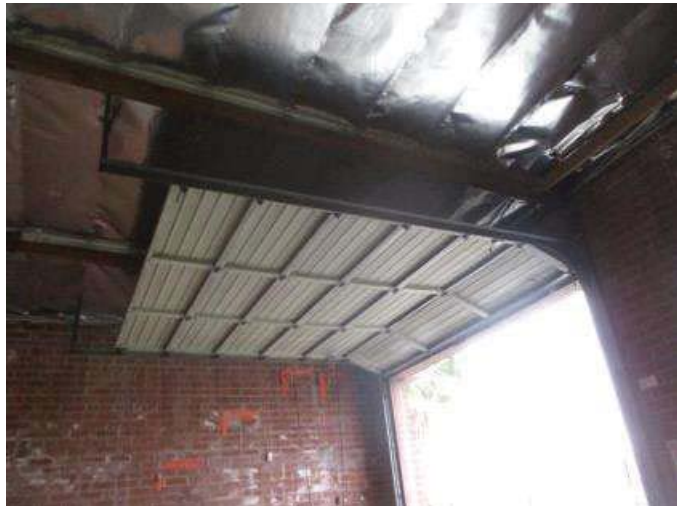
Serviceable.

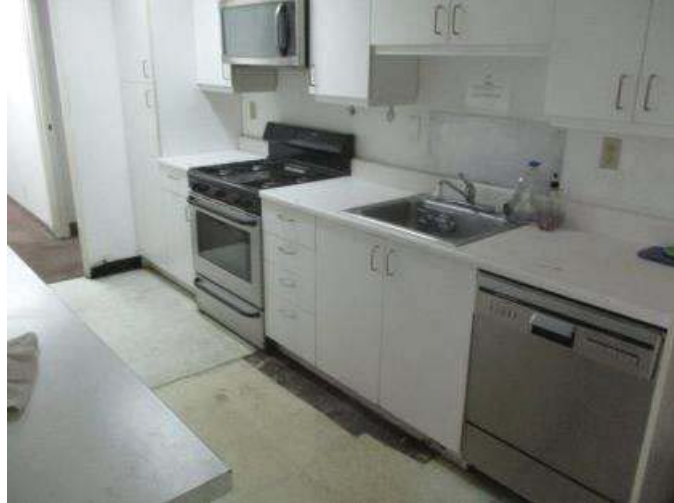
This kitchen is showing excessive wear.

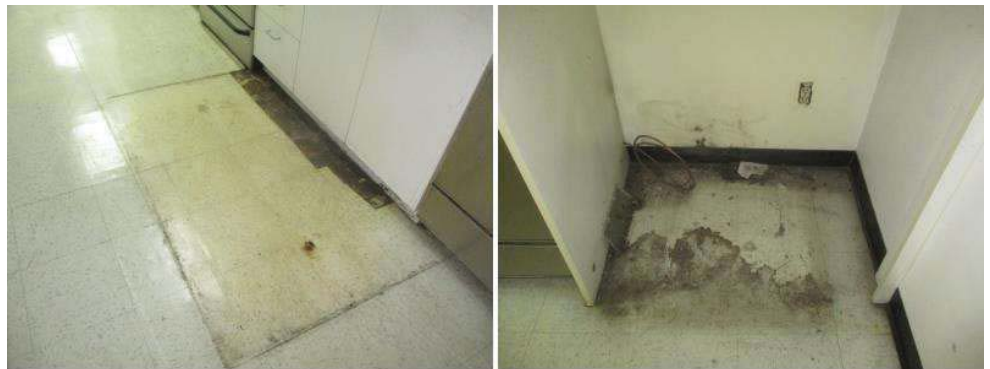
Needs Attention:

There are cracked/chipped floor tile.

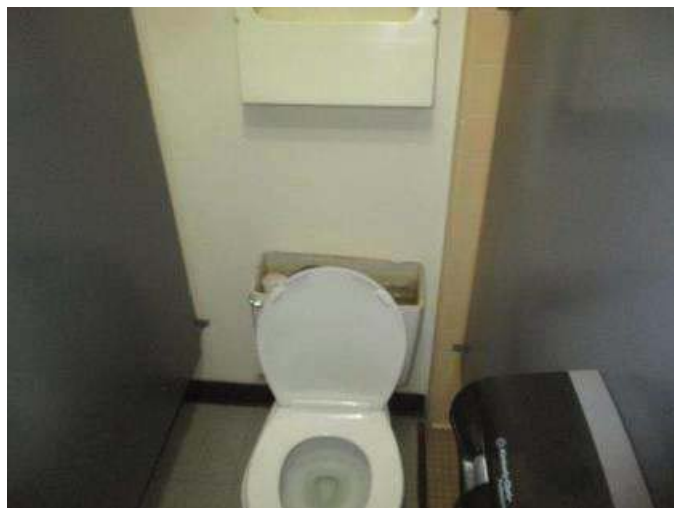
The toilet is worn and/or damaged.

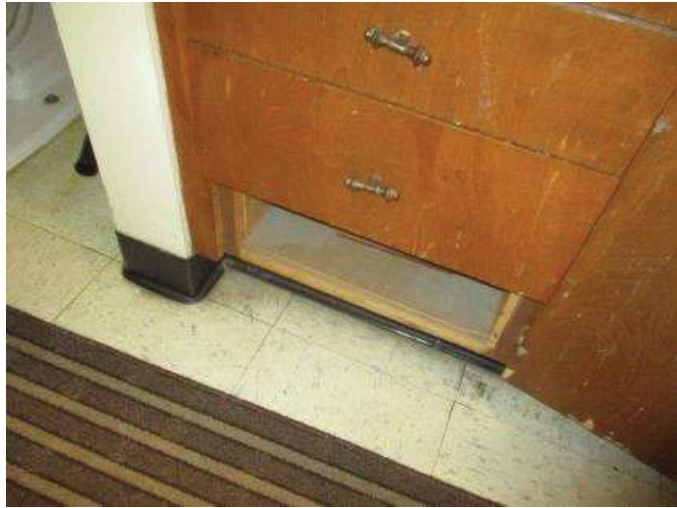
The bathroom cabinet is damaged.

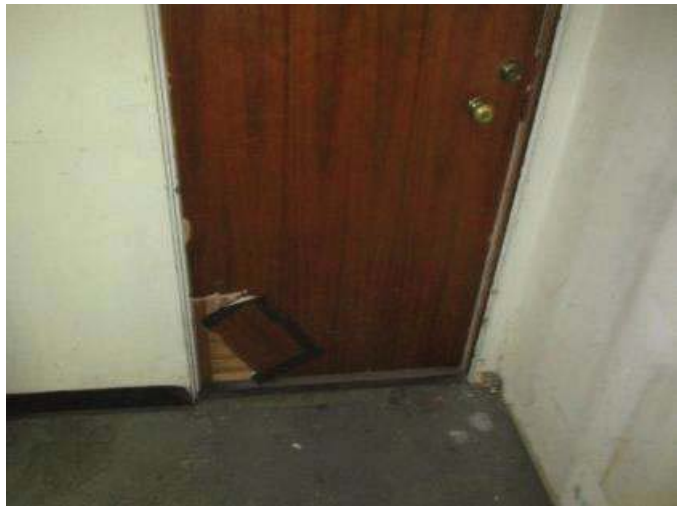
Needs Attention:

The interior doors generally need adjustments and/or repairs to function properly.

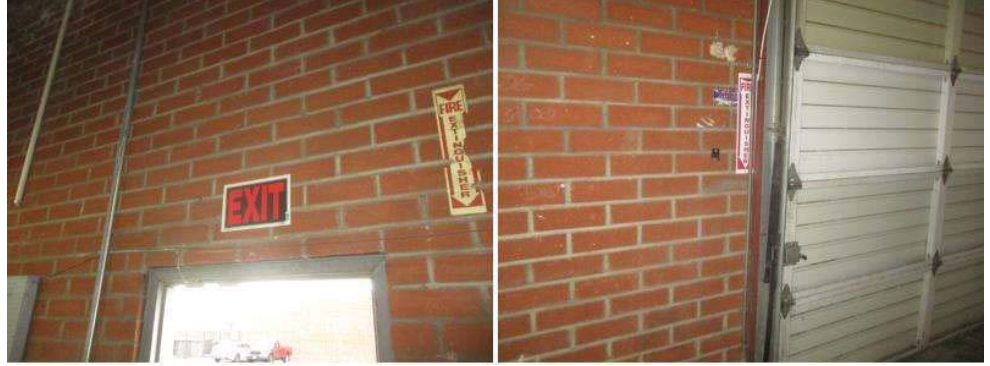
This type of building site is required to have certain fire safety items. These are items such as exit signs and fire extinguishers. It is advised to check with the local Fire Marshal to determine if this building meets current fire safety regulations.
