RISK Assessment® Report

RISK ASSESSMENT®

ADDRESS: 8125 Lankershim Blvd. North Hollywood, CA 91605

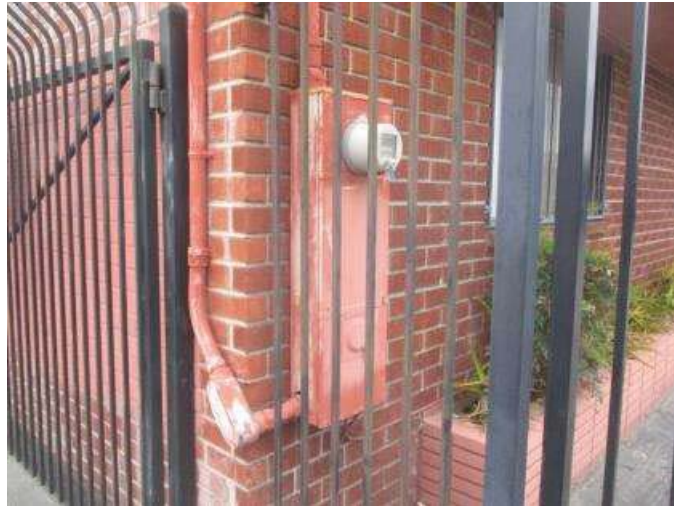
PANEL LOCATION:

The main electrical panel is located on the front exterior of the building.

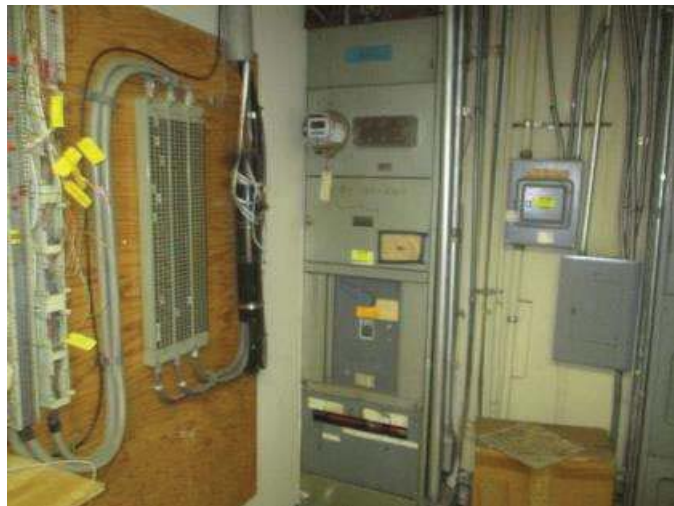
The main electrical supply panel is in an electrical room inside the building.

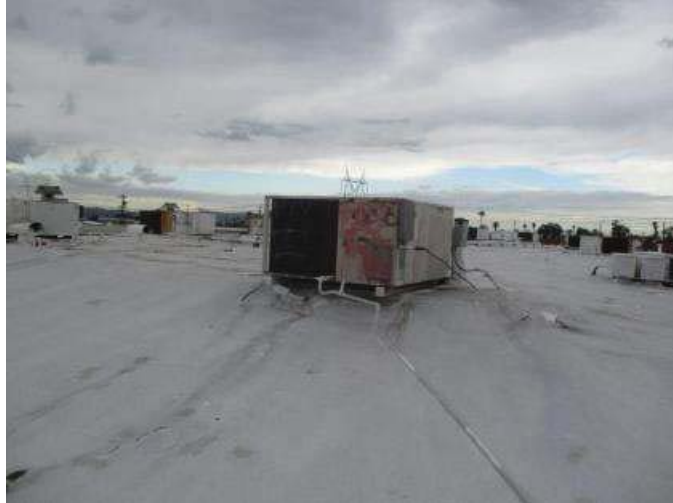
LOCATION:

The heating and cooling units are located on the roof.
