RISK Assessment® Report

RISK ASSESSMENT®

ADDRESS: 8125 Lankershim Blvd. North Hollywood, CA 91605

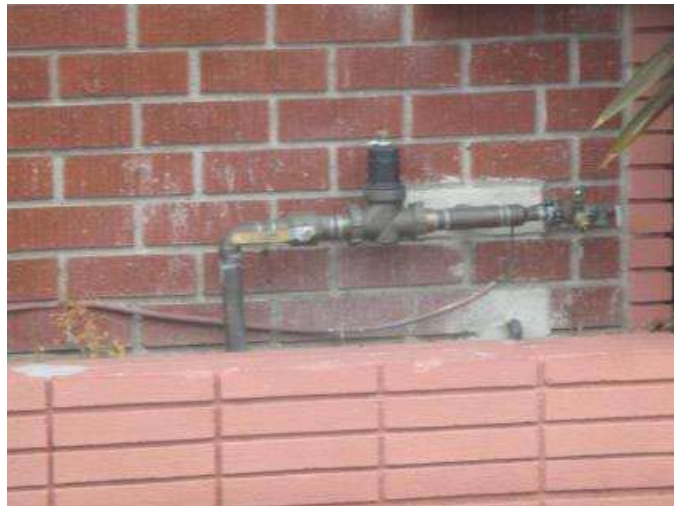
MAIN WATER SHUT OFF
LOCATION:

At the front of the building.

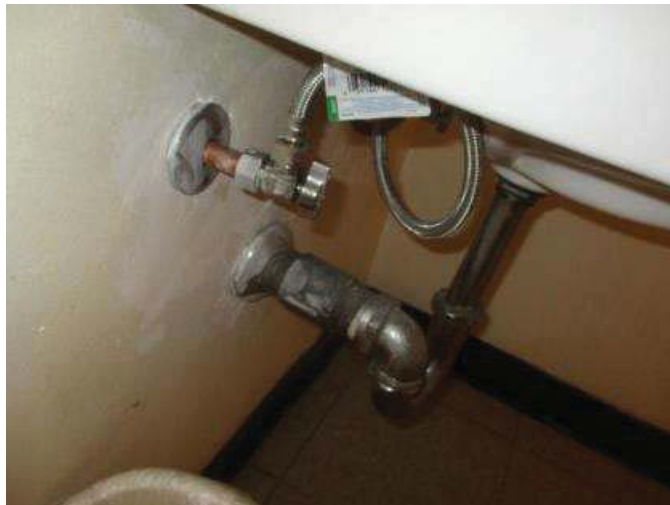
WASTE LINE MATERIAL:

The piping that takes the waste water to the sewer system is a combination of different materials where viewed.

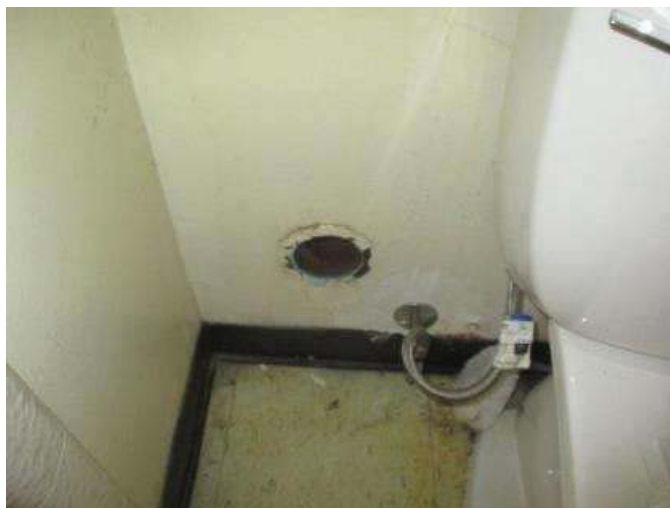
MAIN SEWER CLEANOUT:

A main waste line cleanout was located in the Restroom.

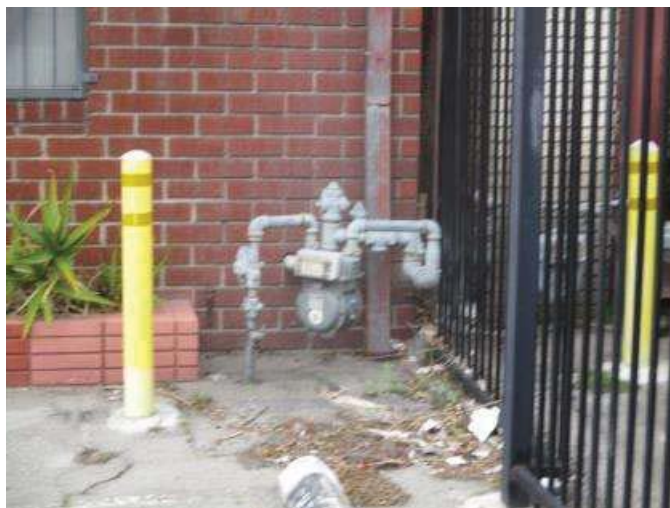
GAS METER LOCATION:

The meter is located on the right side of the building.

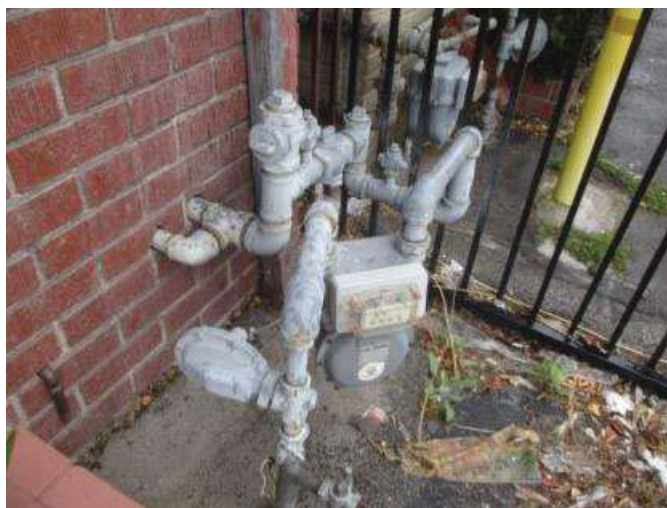
SEISMIC GAS SHUT OFF
VALVE:

There is no automatic seismic gas shut-off valve on the main gas line. It is advised to have this installed for health and safety purposes.

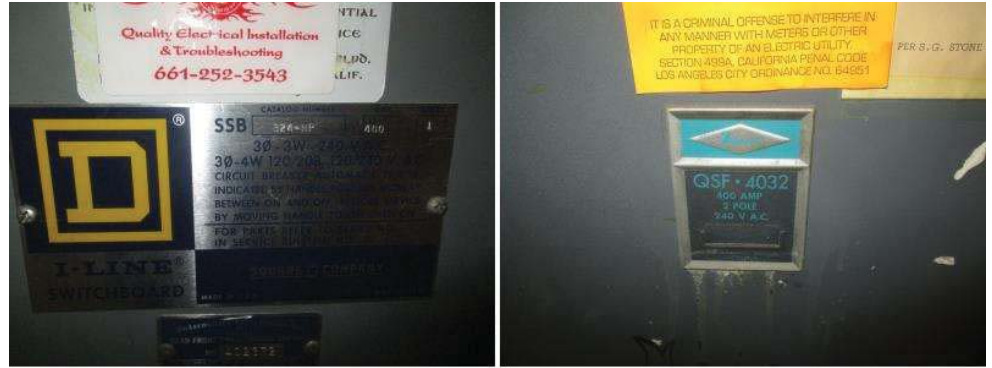
MAIN PANEL SPEC'S:

120/240 volts.

This is a single phase, 3 wire system & This is a 3 phase, 4 wire system.

Service Amperage rating - 400 / 400 / 200

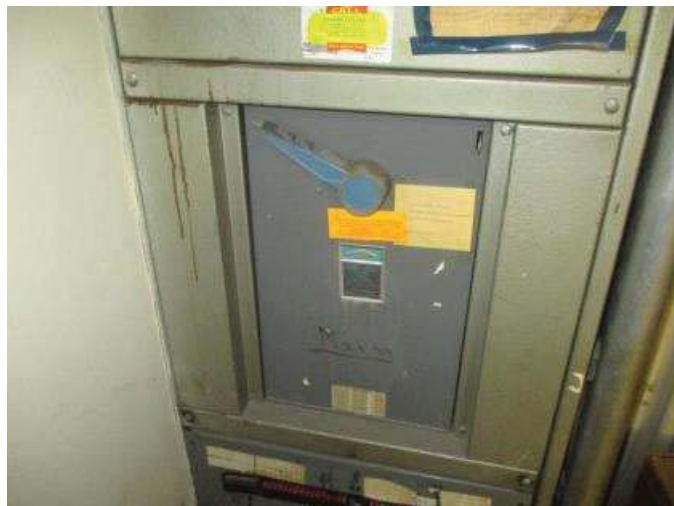
MAIN PANEL PROTECTION DEVICE:

The main panel disconnect is a lever.

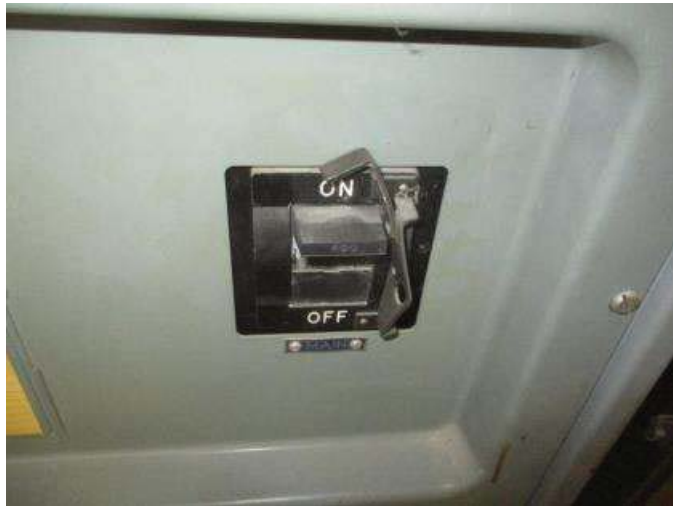
The main panel disconnect is a circuit breaker.

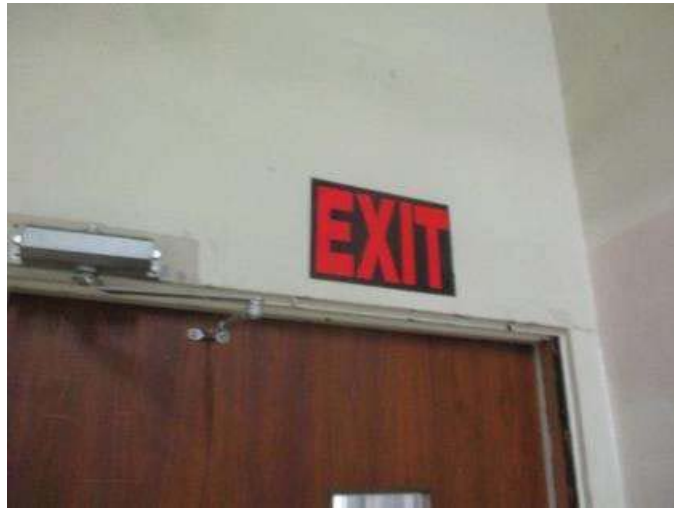
EXIT SIGNS:

Needs Attention:

Although there are signs present, they are not of the type that are required by current standards.

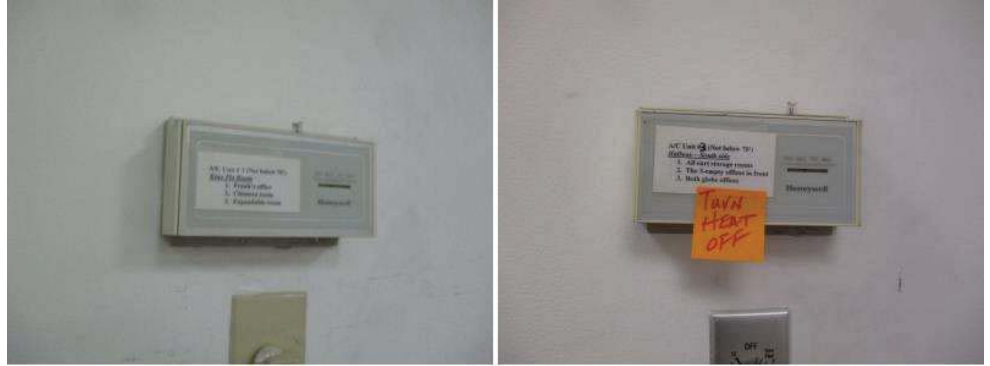
THERMOSTAT:

Needs Attention:

The system did not all respond with the thermostat controls at the time of inspection.

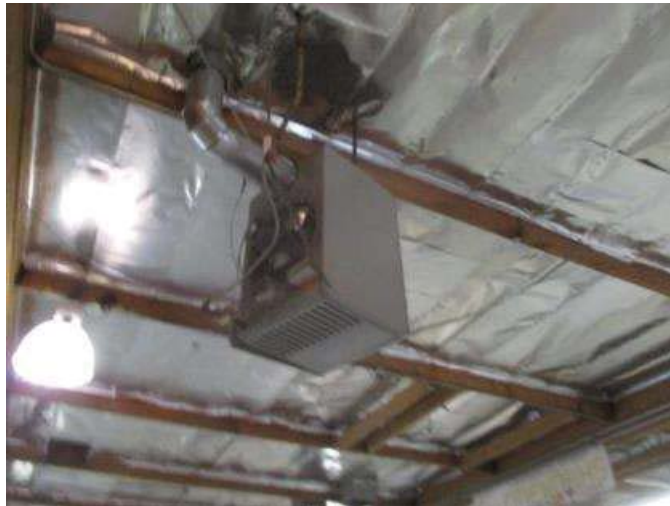
LOCATION:

The unit is an open warehouse gas furnace that is suspended from the ceiling.

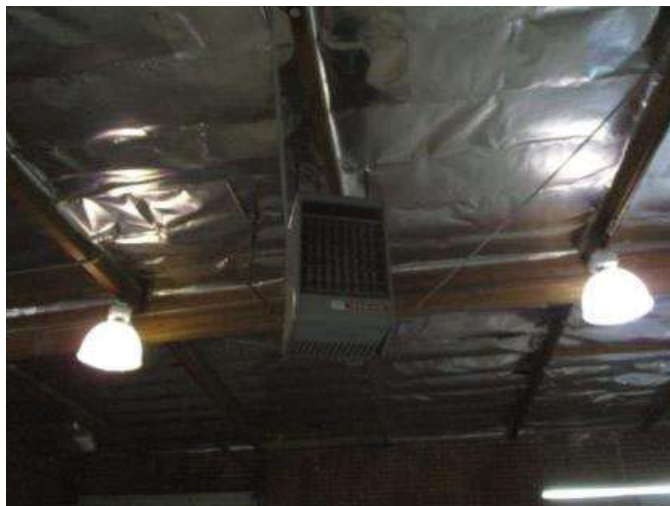
SYSTEM AGE:

It is unknown how old the unit is, but it appears older.

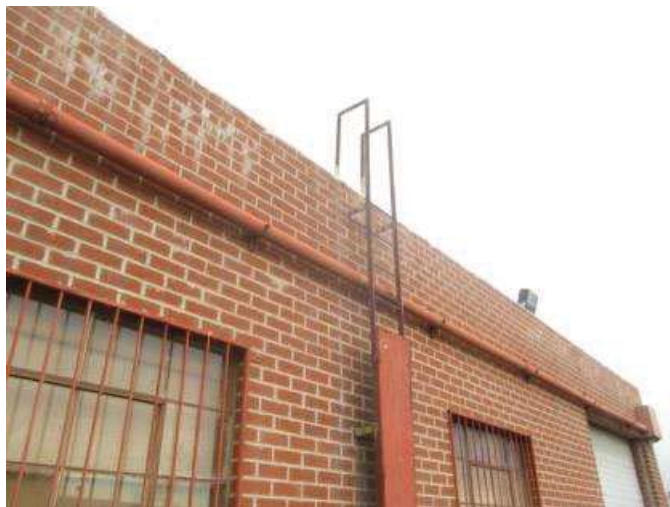
ACCESS TO ROOF:

The access to the roof is via a ladder that is attached to the building.

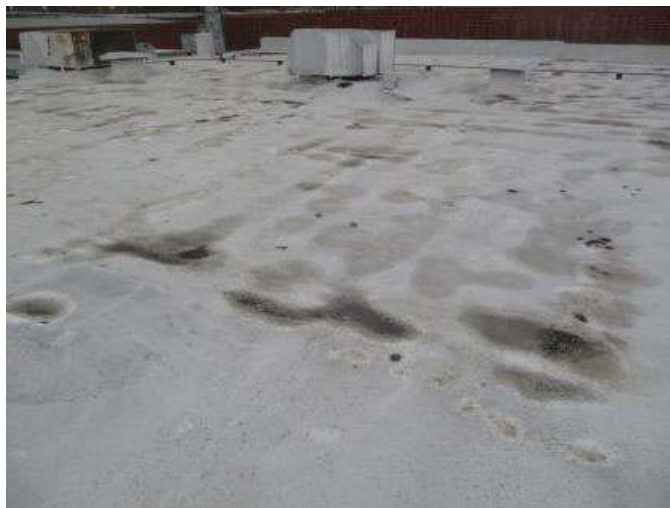
ROOF STYLE:

The roofing system has a Low Slope to it. This means that the slope of the roof appears to be no more than 2" of rise for every 12" of horizontal measurement.

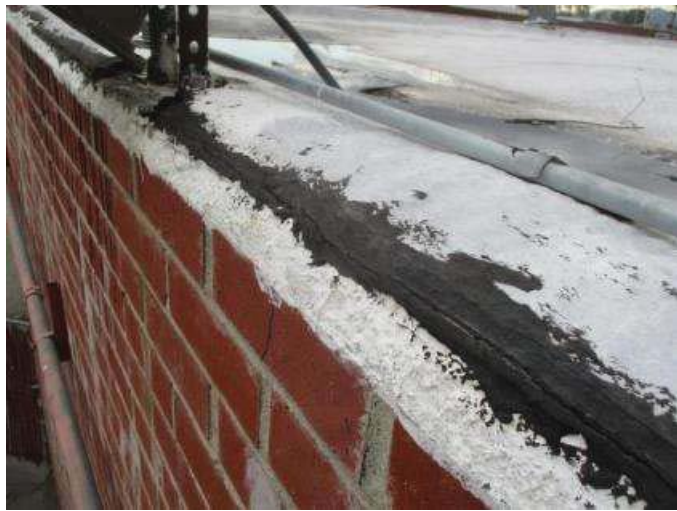
Needs Attention:

It is noted there are areas of the roof that have had patching and or repairs done to them. This is usually an indication that there have been leaks and past issues. It is advised to have full disclosure by the seller as to the history of any roof leaks.

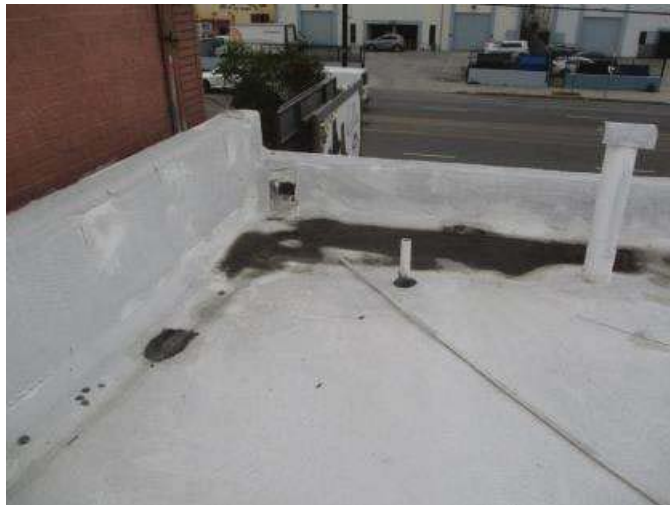
ROOF DRAINS:

The drains appear to be higher than the immediate surrounding area which promotes standing water from rains. It is advised to have the drains lower than the surrounding areas so that water does not stand during and after rains.

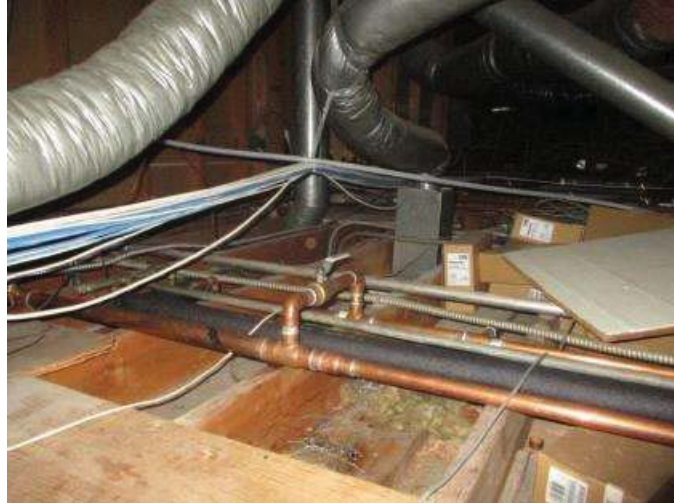
AREA OF ATTIC:

There is an attic space over part of the floor plan of the building.

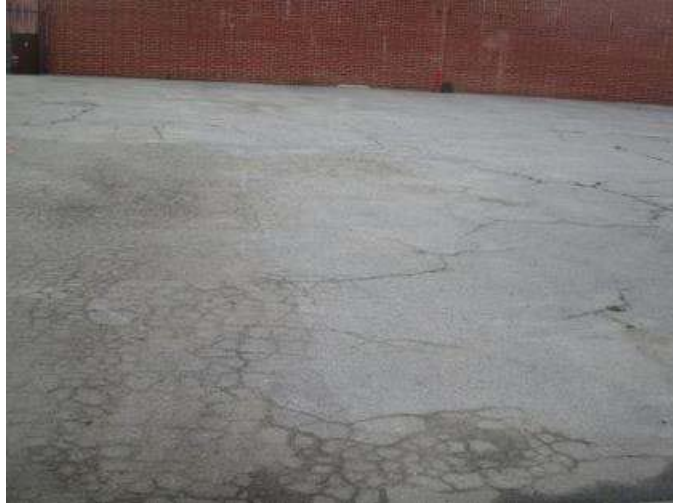
SITE:

Relatively flat site.

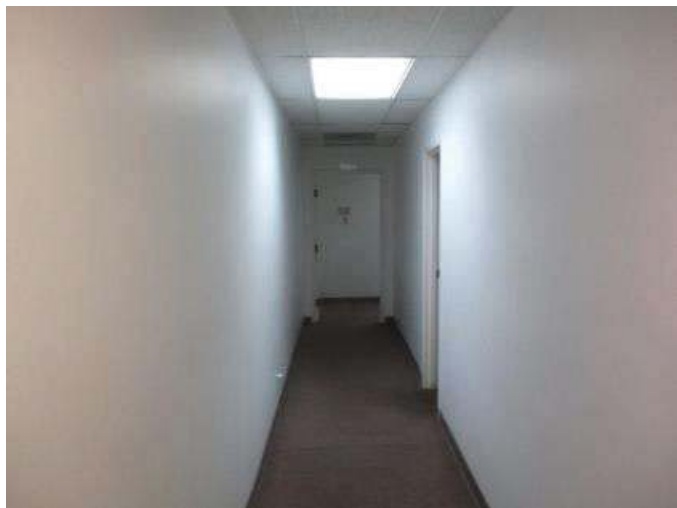
HALLWAYS:

The areas are generally aged, but remain serviceable overall.

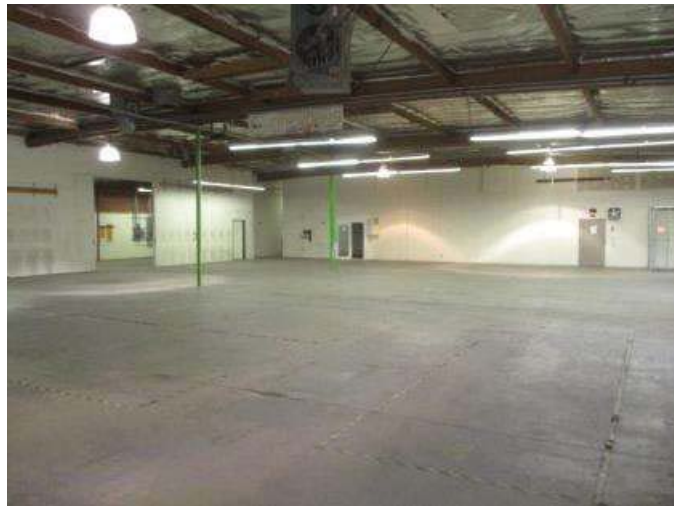
WAREHOUSE AREAS:

This area is generally aged, but remains serviceable overall.

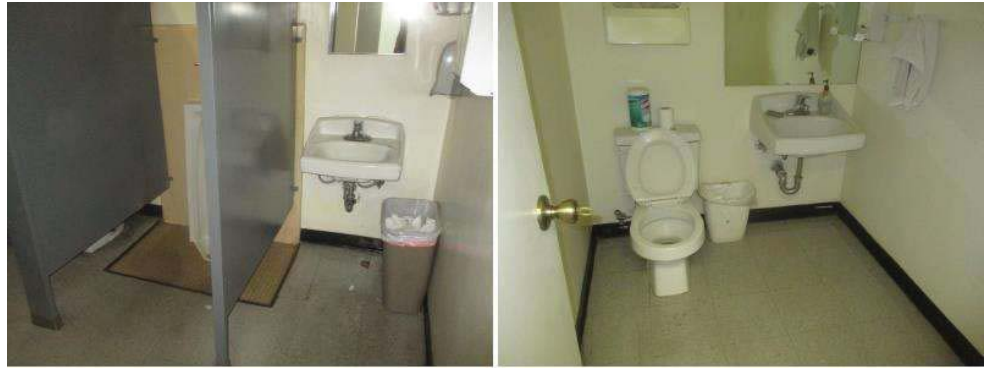
INTERIORS:

Though outside the scope of a general visual inspection the bathrooms do not appear to be up to current ADA requirements. This is mentioned as a courtesy however further review by a qualified ADA specialist is advised to determine the best course of action for this site.
